CORINTH

VOLUME X

THE ODEUM

OSCAR BRONEER

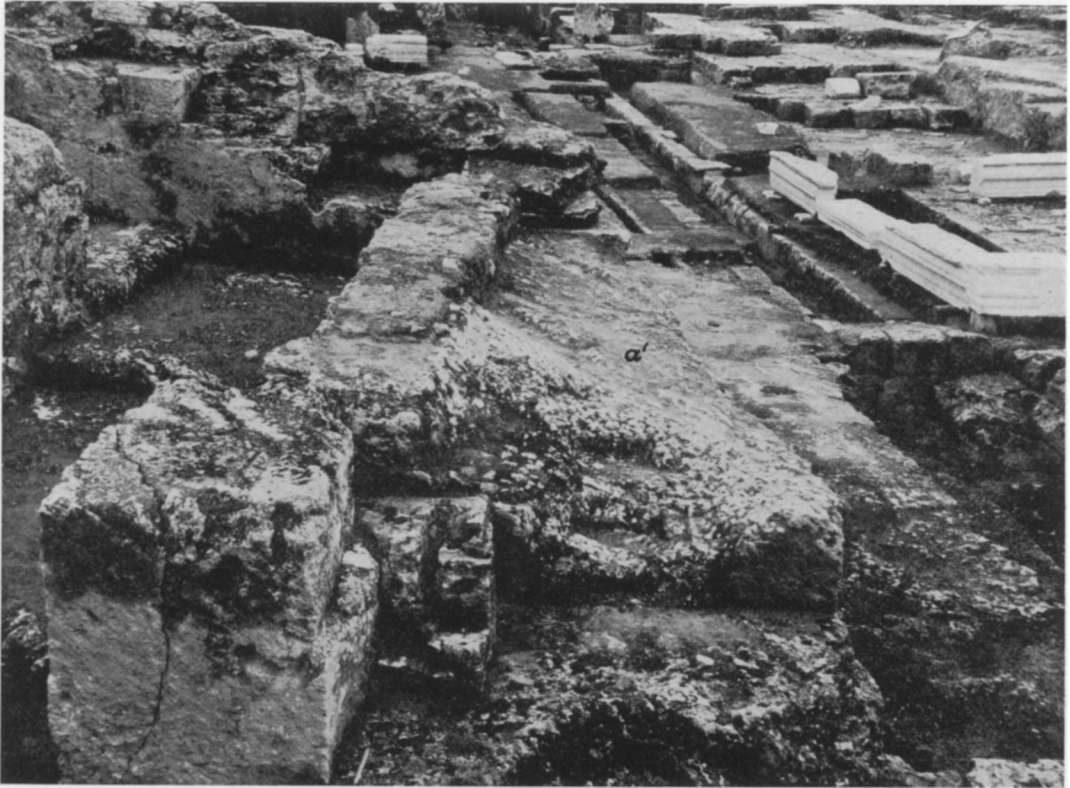
FIGURE 2. EARLY ROAD NORTH OF EAST STAIRWAY

on which the seats once rested has led to the discovery of two roads which date back to the pre-Odean period. One of these is clearly visible on the north side of the east stairway (marked *a'*, PLATE III and Fig. 2) and under the western part of the cavea east of pier 18' (PLATE III a and Fig. 3). Its continuation toward the west can be traced at the edge of the excavated area opposite pier 19 (PLATES II and III), but toward the east

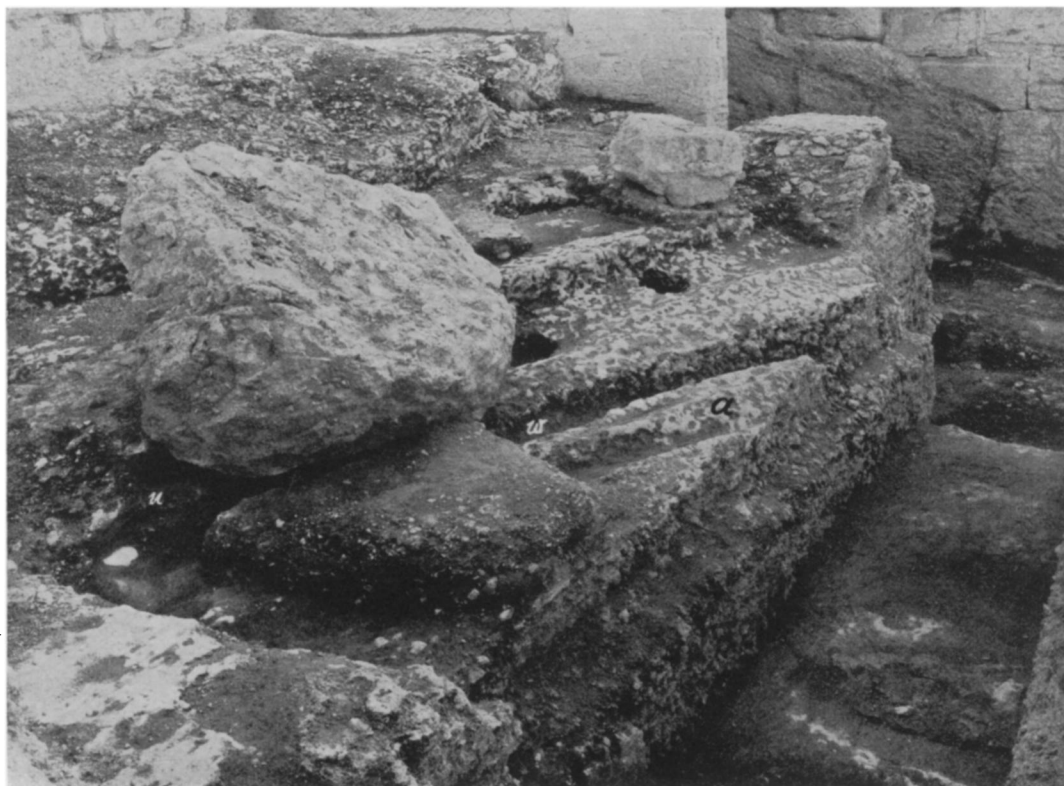
FIGURE 3. EARLY ROAD IN WEST PART OF CAVEA

it is still hidden by a later Roman road-bed at the very edge of which a wheel rut of the earlier road appears (PLATE XII). That the road must have been of some importance is shown by the fact that it was partly cut artificially in the rock where the slope of the hill was too steep for the wagons to pass over. The course of the road changed slightly from time to time, so that gradually it ran lower down on the slope. Between the wheel ruts in the western part of the cavea a trench *w* (PLATE III and Fig. 3), ca. 0.25 m. wide and ca. 0.18 m. deep, was cut in the rock, and through this trench passes a terracotta pipe *u* (PLATE III and Fig. 3) with an inner diameter of 0.075 m. The pipe, which is made in sections, 0.30–0.33 m. long (Fig. 4), is of a type that was used in Corinth during a long period and does not differ much from the water pipes used in Greece today. No stamps have appeared on any of the sections, hence we have no definite clue to the date of

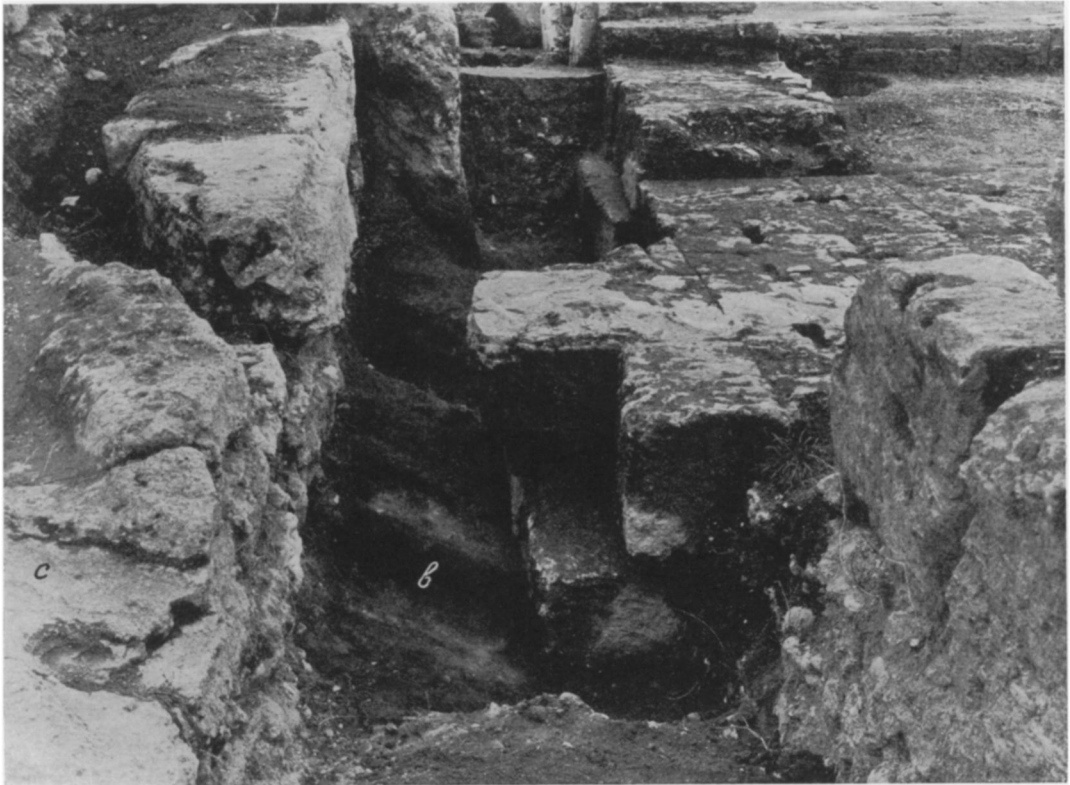
FIGURE 5. TRACES OF ROAD AT NORTHEAST CORNER OF ODEUM

On the east side of the Odeum another early road runs in a southeast to northwest direction. The earliest traces appear at the northeast corner of the Odeum, where the deep ruts, worn in the rock, are cut off by the foundation for the east wall of the scene-

It is difficult to determine whether these two roads are Greek or Roman, but there is evidence for showing that the one on the east side, *b*, was in use until the building of

the Odeum. Two later periods of the same road can be distinguished. After the erection of the Odeum the ground level on the east side was raised and the road passed along the east façade of the building, following very nearly its old course and, turning at the corner of the scene-building, continued approximately in a westward direction. This road-bed is easily distinguishable where it makes the bend (Road *c*, Figs. 5, 6, and PLATES II, III), and its hard surface appears in the earth upon which rest the mosaics of room P (PLATES II and III). In the second period of the Odeum the road again changed its course. A large court surrounded by colonnades (see p. 67) then occupied the area between the Odeum and the Theatre, and the road, continuing its course due north, ran along the east side

wall does not fit that of the east wall. The outer face of the east wall is shown in figures 5 and 23, the inner face in figure 24 and in Section I-J, PLATE V. In figure 23

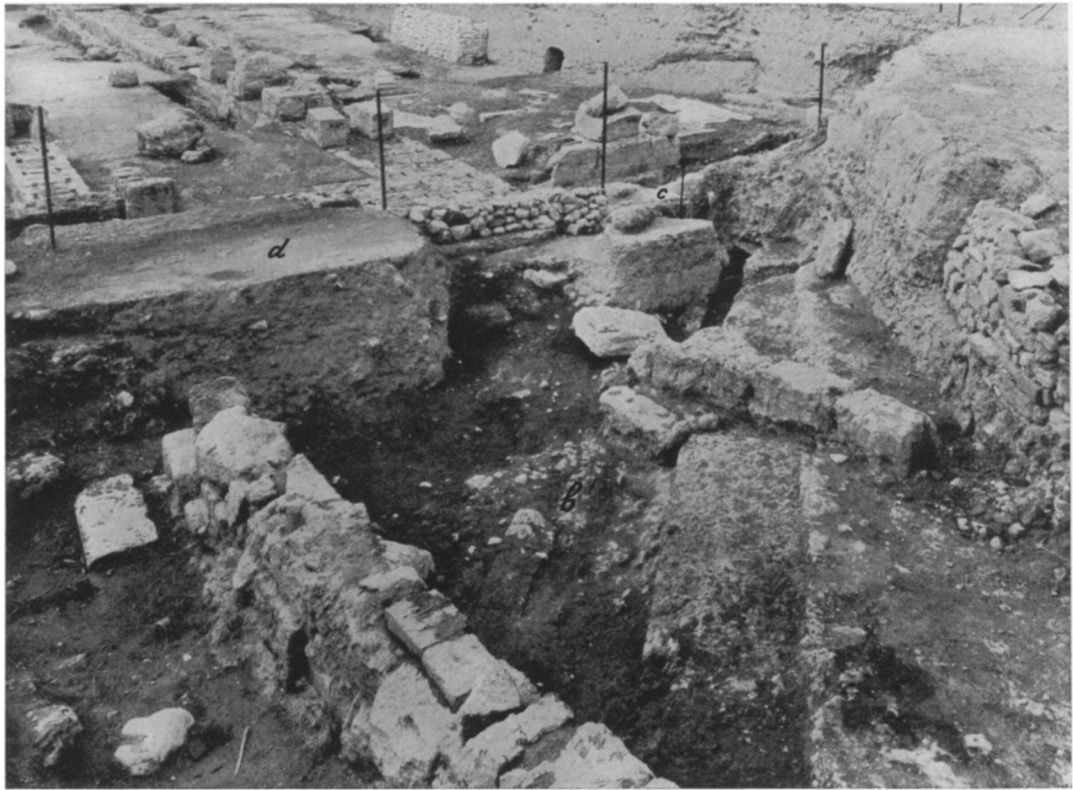
FIGURE 6. ROADS EAST OF ODEUM

of the Theatre, where it has been laid bare through the recent excavations of Dr. Shear.¹ Where it approaches the east *parodos* of the Theatre, it is paved with limestone blocks; but its upper portion near the Odeum seems never to have been paved. Here it consists of packed earth very hard and level, hence its course can easily be determined (Road *d*, PLATES II, III, IX, XII, and Fig. 6). It continued toward the south as far as the stairway

that led to the higher area south of the Odeum, where it turned eastward in the direction of the Agora; but beyond the stairway it is for the most part destroyed.

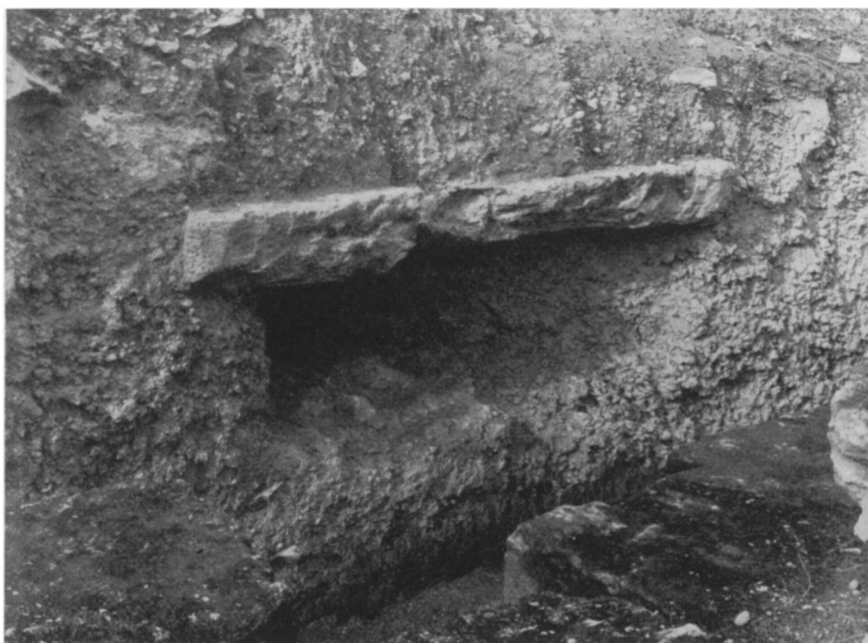
FIGURE 7. ROCK-CUT GRAVE WEST OF ODEUM

Two early graves were discovered in the area of the Odeum, both of them destroyed and their contents removed at the time when the building was erected. When the trench for the outer wall of the cavea on the west side was made, one of the graves was cut through; but a corner is still to be seen in the scarp of rock opposite pier 20 (PLATE III). It consisted of a rectangular cist (Fig. 7) cut in rock and covered with a single slab of hard conglomerate. The grave measured 1.40 m. in length, at least 0.60 m. in width, and 0.48 m. in depth. Nothing of its contents remained; but some soft black earth was found in the corner. The second grave was cut through by the man-hole in the north central porch. It is indicated in Section A–B, PLATE IV. This grave measures 1.38 m. in length, 0.50 m. in width, and 0.67 m. in depth. About half the cover slab is preserved. In the

been recently excavated, the type of grave which most resembles those in the Odeum is a transitional variety between the Geometric and Protocorinthian periods.² The single cover slab of hard conglomerate is not found in any of the other kinds of graves from the cemetery.

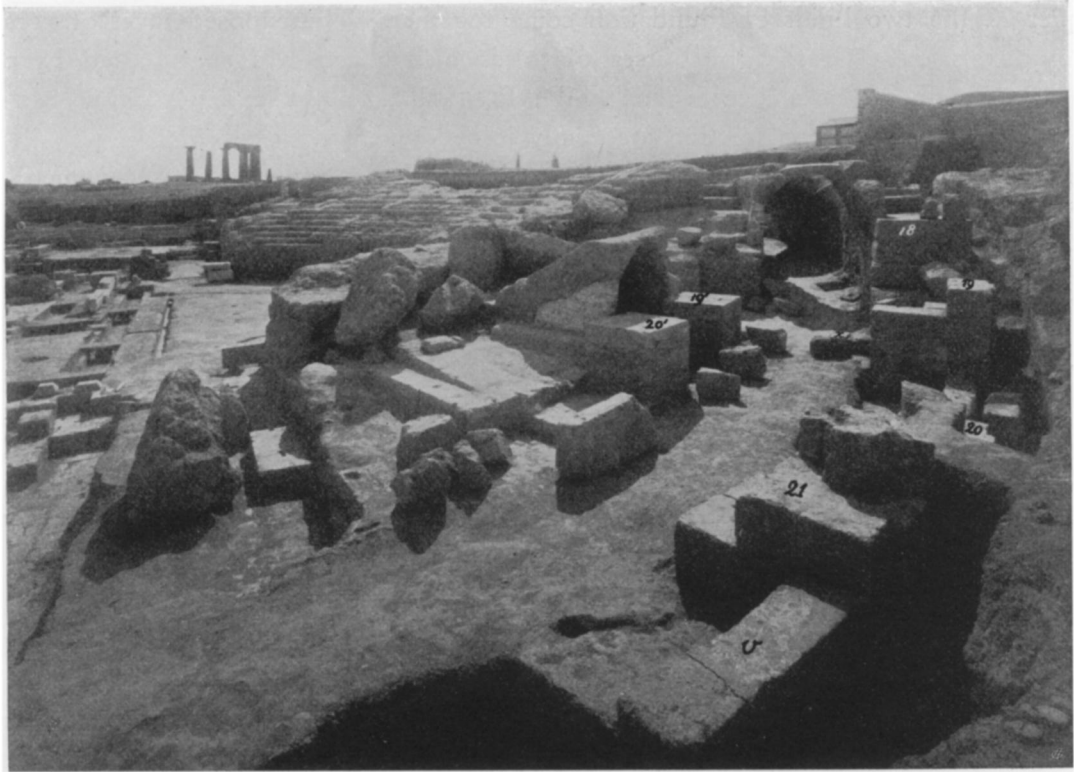
FIGURE 8. ODEUM, SHOWING WEST PART OF CAVEA AND SEMICIRCULAR CORRIDOR

their exact place can be calculated. The thin screen wall between this last outer pier, 22, and the next pier to the south, 21, exists (PLATES II, III ν , and Fig. 8 ν) and shows that the distance was the same as that between the other piers in the same wall. It follows that pier 22 was not placed according to the direction of the *parodos* wall but, like the other piers, according to the radius of the orchestra circle. This is further shown at the east end of the semicircular corridor, where the corresponding piers 1 and 1' are preserved. The inner piers 1' and 22', however, were oriented with reference to the *parodos* wall (PLATES I–III).

The foundation for the outer wall is very massive, having a width of 3–3.50 m. The lower part is made of hard concrete, on which rests a single course of *poros* blocks with irregular jointing and without clamps. Below pier 22 all the *poros* blocks have been removed, leaving the concrete foundation exposed. The foundations of the scene-building (except that for the north façade, see p. 33), unlike those of the cavea, are made of *poros* blocks laid in mortar and resting directly on the rock without the concrete bedding. At pier 22 the two kinds of foundation come together. The exposed layer of concrete actually rests on at least two courses of *poros* blocks and was surmounted by three courses of similar blocks (see Section C–D, PLATE IV, on the extreme right). In this way the two kinds of construction are firmly joined together.

The foundation projects on the outside ca. 1 m. beyond the face of the piers, but only ca. 0.30 m. on the inside. On this broad foundation the piers are built of large *poros* blocks, which are joined by dove-tail clamps laid in mortar. The clamp holes have a length of ca. 0.32 m. and a width of ca. 0.09 m. at the ends and ca. 0.07 m. at the middle. In the numerous holes of this kind which are visible throughout the building (PLATES II, IX, X, and Figs. 14, 22, 23, and 32) there is no trace of metal. The holes, if undisturbed, are filled with mortar which is hollow in the middle. On the bottom of the hollow space is found some soft black matter from a decayed piece of wood. Iron clamps were used at important junctions of walls (see p. 44), and for fastening the marble blocks; but the common variety in the walls is the wooden dove-tail clamp embedded in mortar. It must have been evident to the architects that clamps of that kind could be of no lasting value for holding the blocks together, hence they were probably intended to be of use only until the mortar, in which the blocks were laid, should become hardened.

From the southeast corner of pier 19 a low wall extends half-way across the vaulted corridor (PLATE III *x*, and Figs. 8 *x* and 9 *x*). Whether it extended to the inner wall of the corridor is not evident; but a rough anathyrosis at the east end of the wall shows

steps led to the landing, from which a run of steps ascended in a westerly direction. This was supported by a slanting vault of *opus incertum* (visible in Section C-D, PLATE IV, in PLATES VI and VII, and in Figs. 8 and 9), which in turn rests on two parallel walls, each ending in a massive pier (19' and 20', PLATE III, and Figs. 8 and 9) toward the vaulted passage. Over the piers no vault is preserved; but it is evident that a stone arch here took the place of the *opus incertum*. The latter ends in a straight line where

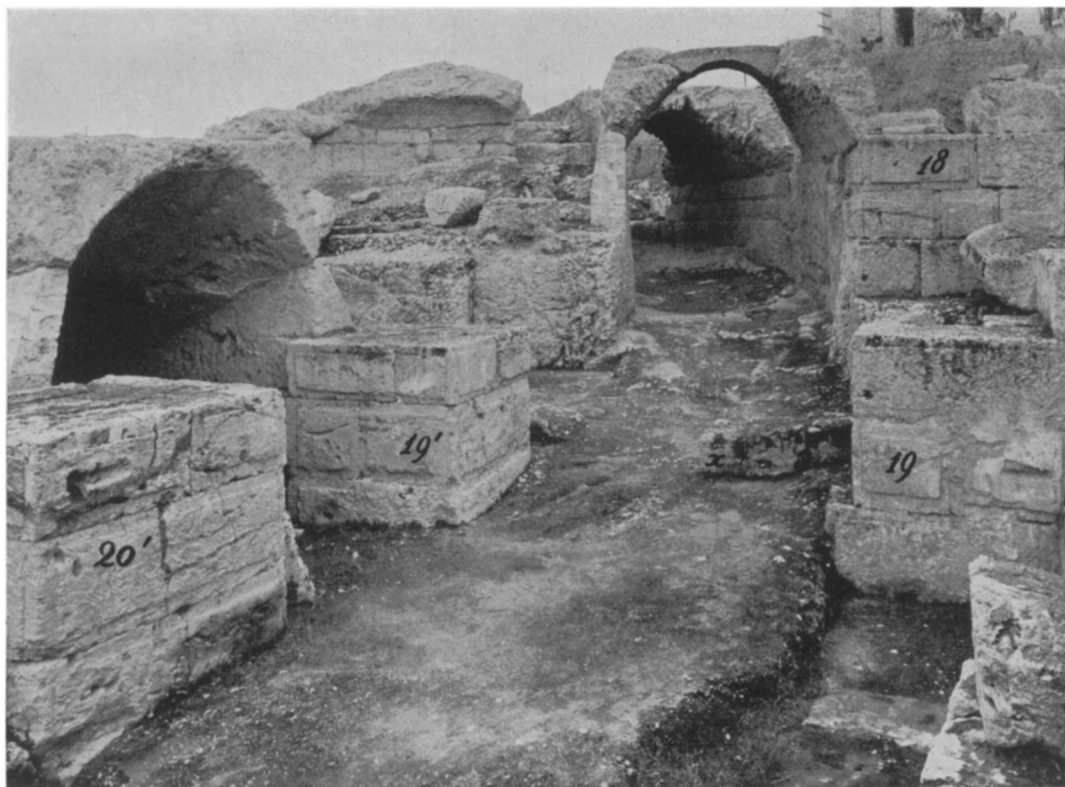
FIGURE 9. WEST END OF SEMICIRCULAR CORRIDOR

The blocks of the piers have drafted edges (Fig. 9), which seems to show that the *poros* was intended from the beginning to be left exposed, but at some period the walls were covered on the inside with white stucco (traces of the stucco appear on piers 19

and 19', Fig. 9). A similar stucco also covers the exposed surface of a large voussoir lying close to the west stairway (Fig. 55, p. 81, No. 7).

that it extended farther east. It is not bonded to the pier; but in the corner between the pier and the cross-wall are traces of stucco. Since both piers 19 and 19' are drafted at the corners in the usual way, the wall was probably added after the piers were already finished but before they received their coat of stucco. The floor of the corridor at this point inclines considerably toward the south (see levels, PLATE III), and one might take the existing cross-wall to be part of a low stairway leading from the lower to a higher floor level. But the floor of the corridor slopes gradually, and there are no traces of a higher floor level on the south side of the wall, nor are there any indications of steps. The wall was originally higher than now, but how high it is impossible to determine. Apparently the semicircular corridor was at one time closed at this point, so that the spectators were not allowed into it beyond the stairway leading up to the cavea.

Beginning with pier 18' and extending toward the south as far as pier 14' the rock rises to such a height that the vault rested directly on it (PLATE III and Fig. 9). Here the corridor is cut through the solid rock; but the sides were left very rough and uneven. The vault as it now stands rests on very thin walls, only about 0.30 m. thick at the springing. But on either side of this concrete vault was a massive poros wall which received the thrust. The outer wall at this height is ca. 1.85 m. wide and the inner wall ca. 1.35 m.

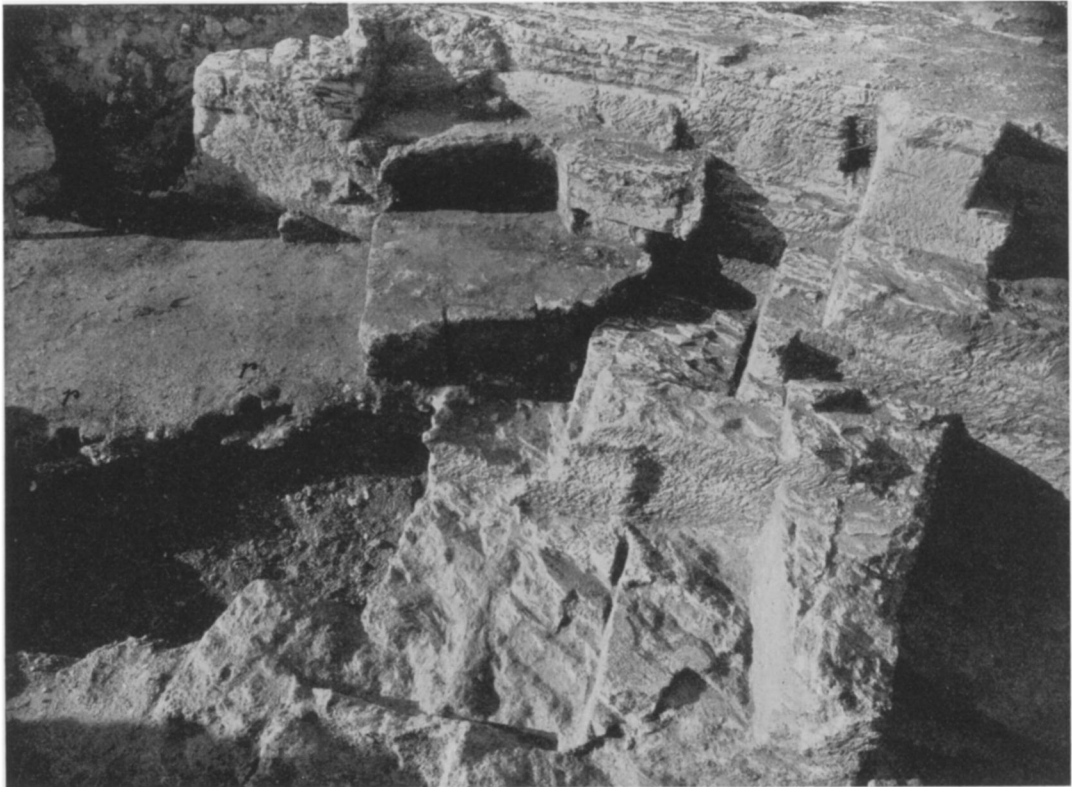
FIGURE 10. QUARRY, SOUTHEAST SIDE, SEEN FROM ABOVE

The way in which the foundations were laid shows that the quarry was already filled up at the time of the building of the Odeum. The two parallel walls and the piers on which rested the vault over the semicircular corridor have foundations extending down to the bottom of the quarry, but the floor of the corridor rests on earth (see Section A-B, PLATE IV). When the foundations were laid, the ground level was considerably higher than the top of the foundations. Through this fill, which contains potsherds of many different periods from Early Helladic times to the first century A.D., separate trenches were dug for each wall, and in them the concrete foundations were laid. Because of the looseness of the fill the sides of the trenches would tend to fall in, making the trenches narrower toward the bottom. To obviate this, a framework of planks and upright posts was constructed, having the width of the foundation. The upright posts are all on the inside with reference to the wall, so that the framework was not a form into which the concrete was poured. Moreover, the horizontal planks were not set close enough together to hold the wet concrete. In several places where a side of the foundation has been laid bare there are only two planks, one above the other, with an interval between the two greater than the width of the planks (see Figs. 11, 12, and Section M-N, PLATE V). The two planks were used near the top of the foundation; for the lower part, the walls of the trench were sufficient to hold the concrete. The framework has, of course, rotted away; but the concrete poured around it has preserved the hollow spaces, with actual splinters of the wood in some cases still adhering to the sides (Figs. 11, 12, and 21). The grain of the wood was so well preserved on the face of the concrete, when the Odeum was first excavated, that it was possible to determine that pine wood had been used. In one instance, even some letters written on the plank had left legible marks.¹ The planks have

Above the concrete, and while this was still wet, was laid a course of *poros* stones without clamps but with concrete filling the joints. The stones are squared blocks, but of different sizes and irregularly laid, so that the joints do not always come at right angles to the line of the wall (PLATES II, III). This top course of the foundation on the south side juts out beyond the face of the concrete (Sections A-B, PLATE IV and M-N, PLATE V, Figs. 11, 14 and 21) and in it holes were cut from the edge, through which the wooden posts projected as shown in figures 10 r, 13, and 14 r. This indicates that the posts

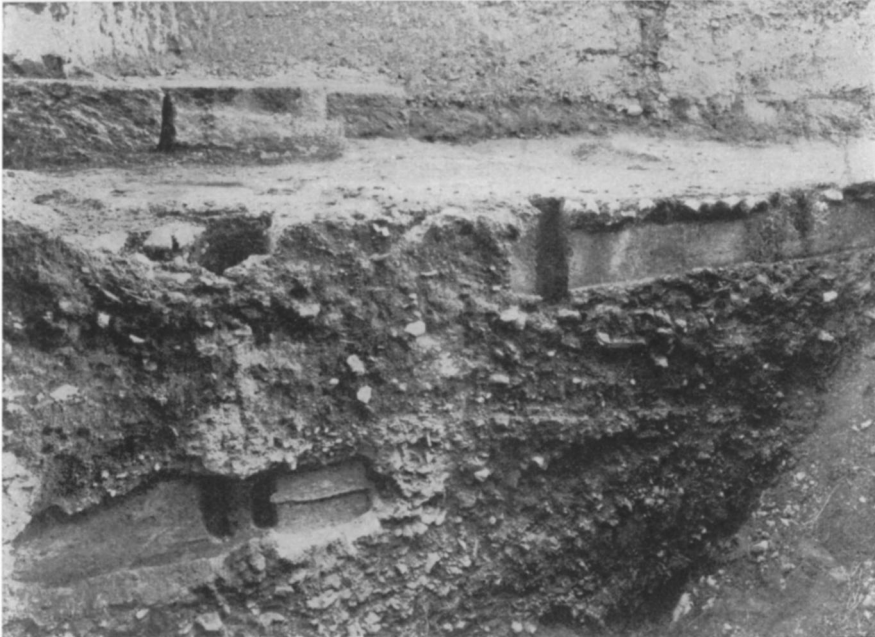
FIGURE 12. FOUNDATION FOR OUTER WALL OF CAVEA, SOUTHEAST SIDE

a thickness of ca. 0.45 m. The upright posts are of two kinds, either semicircular or square in cross section. The former must have been made by splitting a tree trunk in halves, whereas the square kind were hewn on all four sides. In some instances it is evident that both the planks and the posts were hewn, though it is not impossible that for some of the planks the saw was used. The planks were fastened to the supports by heavy iron spikes. The planks and posts thus fastened together may have been further held in place by cross braces; but no trace of these has been found, since they would

The *poros* course which forms part of the foundation on the south side is preserved as far as pier 11, and a few blocks of the same course remain *in situ* farther east. With the exception of these, there remains nothing of the foundation for the outer wall in the east half of the south side except the concrete. It has been possible to study these sub-foundations here more carefully than elsewhere, and to obtain the evidence for the description given above. Several of the holes for the upright posts as well as for the planks used in the construction have come to light in this part of the building. These are visible in PLATES II, III *r*, and in figures 10 *r*, 12, and 14 *r*.

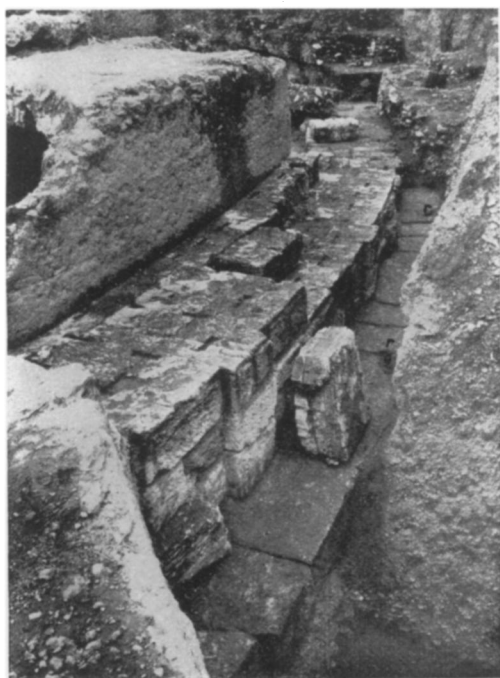
FIGURE 14. OUTER WALL OF CAVEA AND VAULT OVER SEMICIRCULAR CORRIDOR, SOUTHWEST SIDE

The inner wall of the semicircular corridor is made in much the same way as the outer wall. On the west side it consisted of separate piers from which walls extended

like radii in the direction toward the orchestra. On these rested slanting vaults of concrete which formed the substructure for the seats where these could not be cut out of rock. The walls on the south side, which are farther apart than those on the west side, are not true radii of the semicircle. The reason may be that the rooms under the vaults were here intended to be used as storerooms. In the third room from east to west (see PLATES I and III) the two walls are perfectly parallel, and in the fourth room the scarp

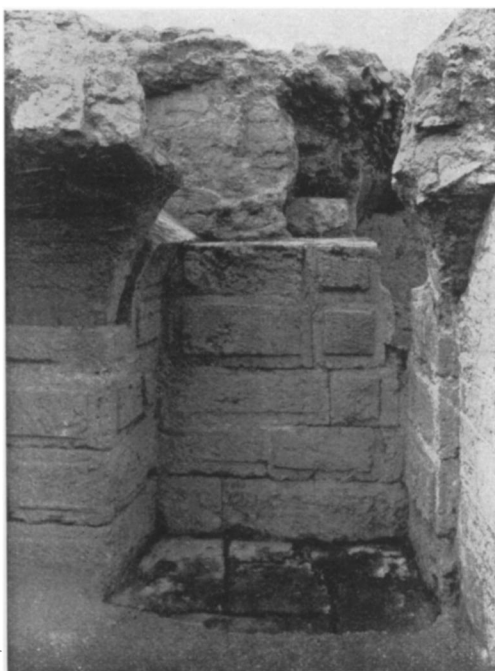
FIGURE 15. NICHE IN INNER WALL OF SEMICIRCULAR CORRIDOR

of rock, which was left very uneven from the quarrying, was made smooth when the walls were built. Furthermore, the face of the walls is well finished, and the joints are touched up with mortar as if intended to be visible. The two small chambers on the extreme east and west sides were probably not used, since here the early fill was found at a level higher than the floor of the corridor.¹ The inner wall of the semicircular corridor is destroyed on the south side; but the rooms must have been accessible from the corridor in some such way as is indicated on the restored plan (PLATE I).² Since the radiating walls on the south side are not spaced according to the outer piers, it seems likely that no piers were here indicated in the inner wall. Between piers 13' and 14' there is a niche, 1.95 m. wide and 0.90 m. deep, surmounted by a stone vault (Fig. 15).

The floor of the niche was sunk ca. 0.20 m. below the floor of the corridor. In the fill of this sunken area and in the corridor close to the niche numerous coins were found, dating from the fourth century A.D. Whatever business may have been transacted here, it is now fairly certain that the niche cannot have served as a ticket office,¹ since there was no entrance into the semicircular passage on the south side. On one of the blocks of the inner wall slightly west of the niche are scratched some lines which seem to have been used as a sundial (p. 141, Fig. 137).

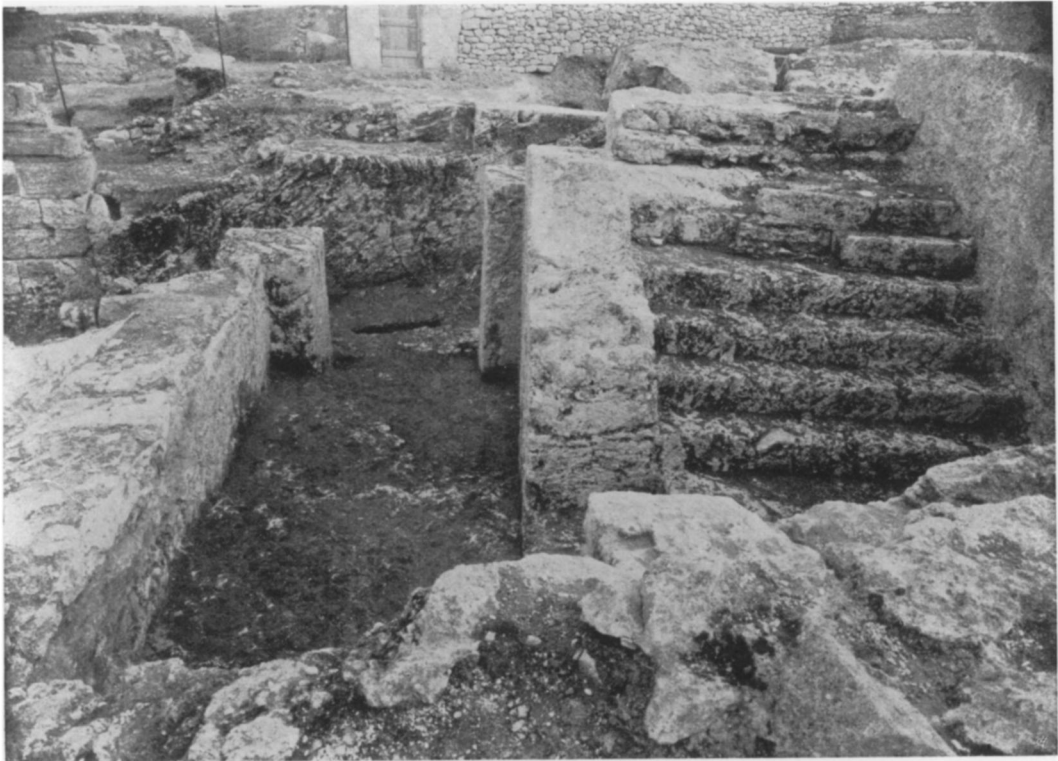
FIGURE 16. EAST STAIRWAY FROM THE WEST

it abutted against the stone arch, and several large voussoirs of *poros* were found in this vicinity.

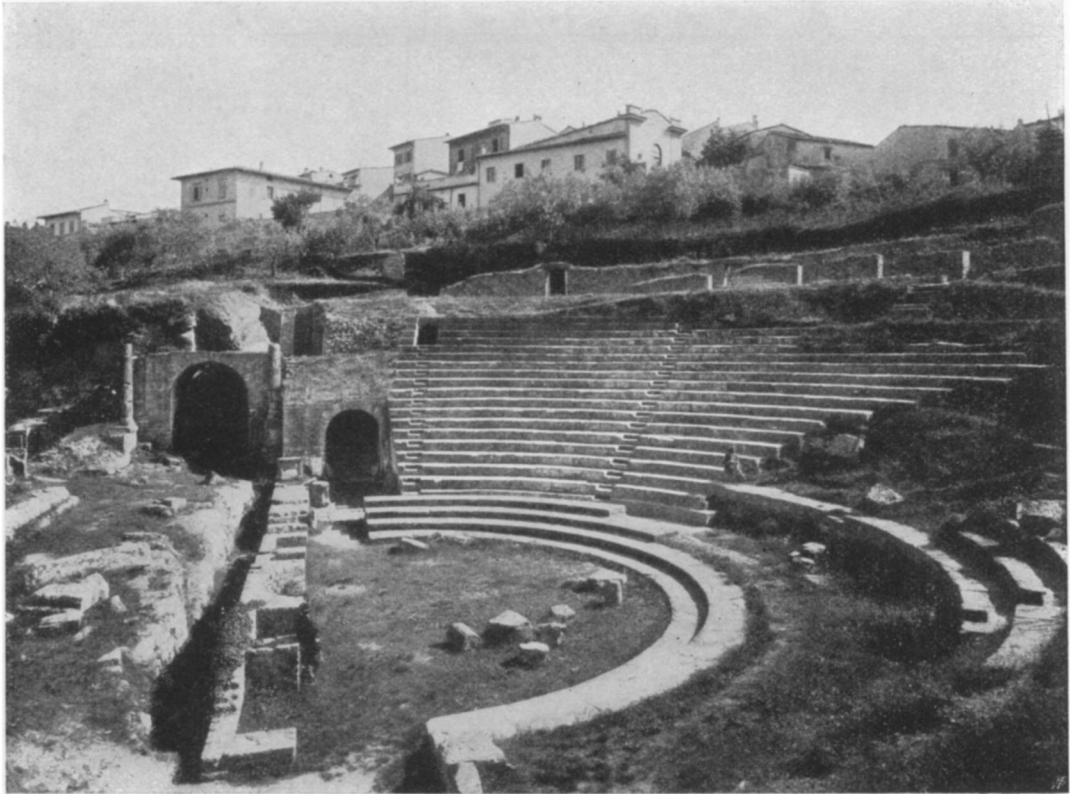
FIGURE 17. ROMAN THEATRE AT FIESOLE, SHOWING VOMITORIUM ABOVE THE AISLE
(PHOTO ALINARI)

¹ The best example is the Theatre at Fiesole (fig. 17) where there were at least four seats on each side of the *vomitioria*. A similar arrangement is found in the Theatre at Herculaneum, the small Theatre at Taormina, and the Amphitheatre at Pompeii. Cf. J. R. Mélida, 'The Roman Theatre of Merida,' *Art and Arch.* XXV, 1928, p. 31.

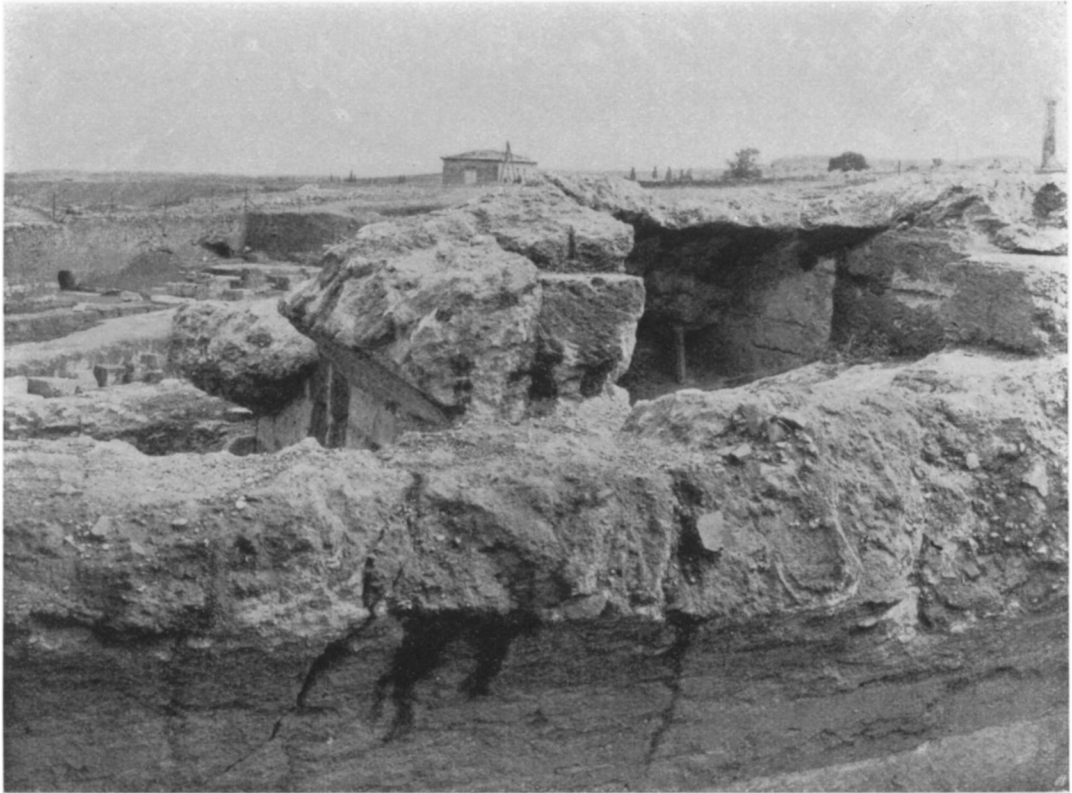
FIGURE 18. HORIZONTAL VAULT BELOW WEST VOMITORIUM (LEFT) AND SLOPING VAULT (RIGHT) TO THE SOUTH

the *vomitorium* at the east aisle is perfectly level (Section A-B, PLATE IV, and PLATE XI), and the same is true of the corresponding vault under the west aisle. Here the top of the vault which formed the floor of the *vomitorium* is broken away except for a small portion at the springing, which suffices to show that here, too, the vault was horizontal (part of this vault appears in Section C-D, PLATE IV, and in figures 8 and 18). Under the central aisle above chamber V (PLATE III) the vault starts from a lower level. It is not perfectly horizontal but makes an angle of about 11° (this vault appears in Section A-B, PLATE IV, in PLATE XI, and in figure 19). Yet this is a much gentler inclination than that of the other vaults, whose mean angle is 28° (not counting the first vault east of the central aisle, which is too poorly preserved to be measured). A section of one of these

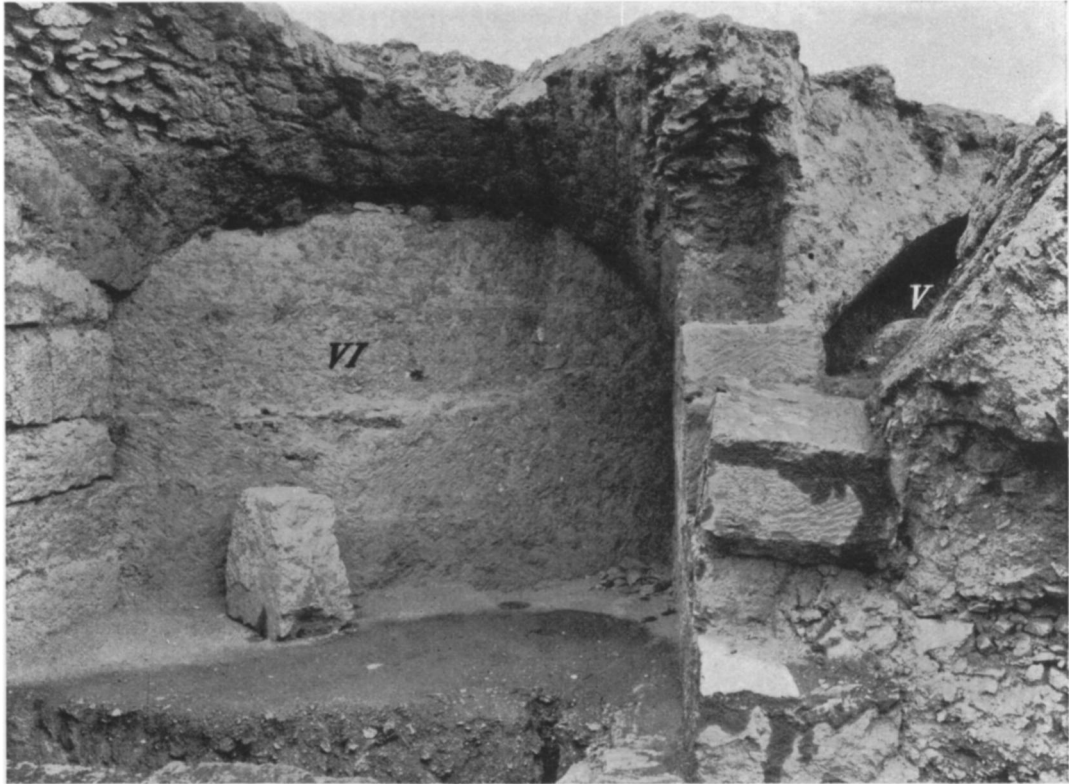
FIGURE 19. VAULTS OVER CHAMBERS V AND VI, SHOWING DIFFERENCE IN SLOPE

vaults is shown in PLATE V, Section M-N. This difference in the slope of the vaults can only mean that there was a horizontal floor above the vaults at the three aisles and that each aisle terminated in a *vomitorium* at a point level with the floor over the semicircular corridor. Thus the existence of a gallery at this level is made reasonably certain. The gallery was entered from the south side (p. 32) and from the east and west stairways of the cavea.

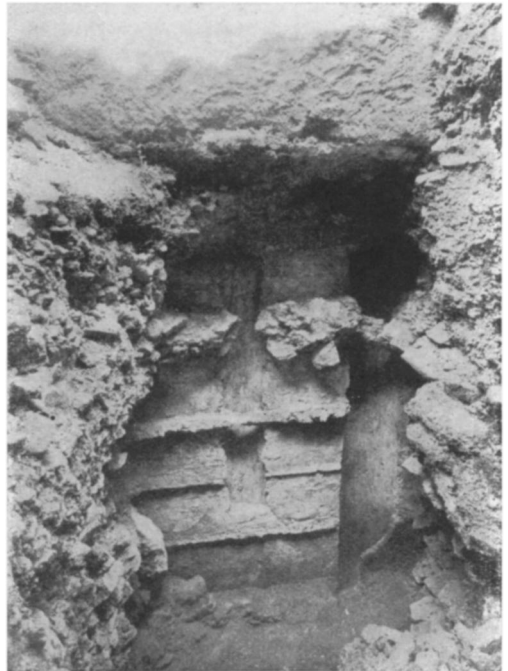
FIGURE 21. FOUNDATION FOR OUTER WALL OF CAVEA, SOUTH SIDE

The south side of the foundation for the outer wall of the cavea was also exposed in this trench (Fig. 21 and Section A–B, PLATE IV). It here presents a different appearance from that shown at other points where it has been laid bare (see p. 17, and cf. figures 11 and 12). The horizontal planks were here set so close together that they must have served as a form for the pouring of the concrete. The upright posts, however, are on the inside, consequently the form must have been held in place by earth packed against it on the outside.

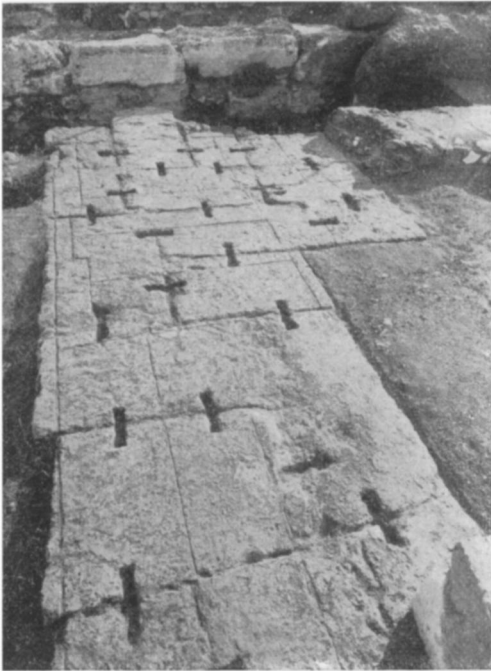
FIGURE 22. N. E. CORNER OF SCENE-BUILDING, SHOWING SETTING LINES ON TOECHOBATE

on the topmost of which rests the first course of wall blocks at the very corner of the building. The two upper courses of the foundation and the wall block are shown in elevation. Here the *poros* blocks of the foundation rest directly on rock and bonded into them is the concrete foundation of the north wall, which is seen in longitudinal section.

The top course of the foundation for the north wall is preserved from its east end to some seven metres west of the axis, whereas in the western part only the concrete sub-

foundation exists (PLATES II, III, VII, and IX). This *poros* course, on which the superstructure rested, was levelled off smoothly on top, and the setting lines for the first wall blocks were scratched in the soft *poros*. These lines, which in some places appear to have been accentuated by a dark pigment, are indicated in PLATES II and III, so far as they can be determined. They reveal a system of piers, 1.20×1.48 m. in section, connected by screens 0.45 m. thick. Near the east end of the wall, four of these piers and one of the screens are preserved in their lowest courses (PLATES IX and XII, and Fig. 23). The piers, together with their screen walls, formed on the inside a series of niches, 0.70 m. deep and 1.45 m. wide. Perhaps there was a low bench in each niche; for such a bench, though from a very late period, is preserved near the east end of the wall. Each pier had on the outside a pilaster 0.75 m. in width, projecting ca. 0.13 m. from the face of the pier. The pilasters are of about the same size as those on the outer wall of the auditorium,

but on the north wall they come much closer together and the piers are smaller. The screens were not set flush with the outer face of the piers but formed niches on the outside, ca. 0.30 m. deep. At the very east end of the wall the setting lines do not show the same system of piers and screens, and the arrangement is not easily determined (Figs. 22 and 23, PLATES II and III). It is not unlikely that the wall was solid from the east corner as far as the easternmost pier preserved, a distance of 4.85 m. Such a solid stretch of wall would give strength to the construction in the corner and would be architecturally permissible. But the setting lines show that there was a large pilaster, 0.90 m. wide, 1.20 m. from the corner of the building; and there seems to have been a corresponding pilaster on the east wall at the same distance from the corner (PLATES I and II). Exactly how these terminated above and how they connected with the architectural features on the rest of the north wall is a matter of conjecture.

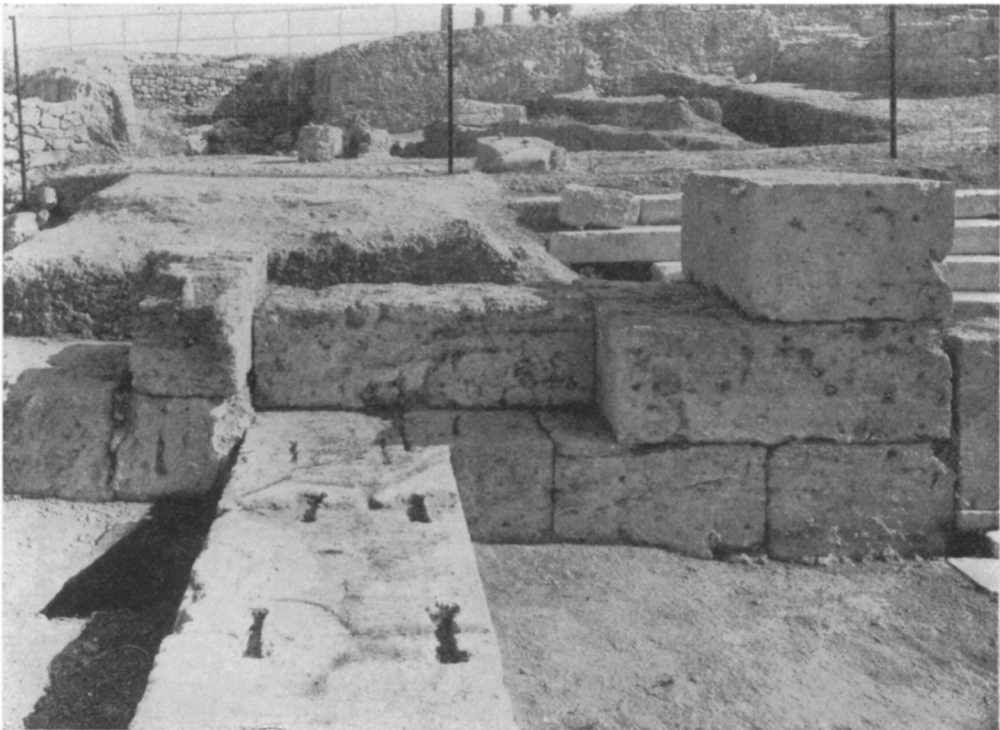
FIGURE 24. EAST WALL OF SCENE-BUILDING FROM THE WEST, SHOWING IRREGULAR COURSING

the change in coursing is clearly visible. Not only is there a change where the east wall abuts against the north wall, but at the pilaster farther south the coursing again changes.

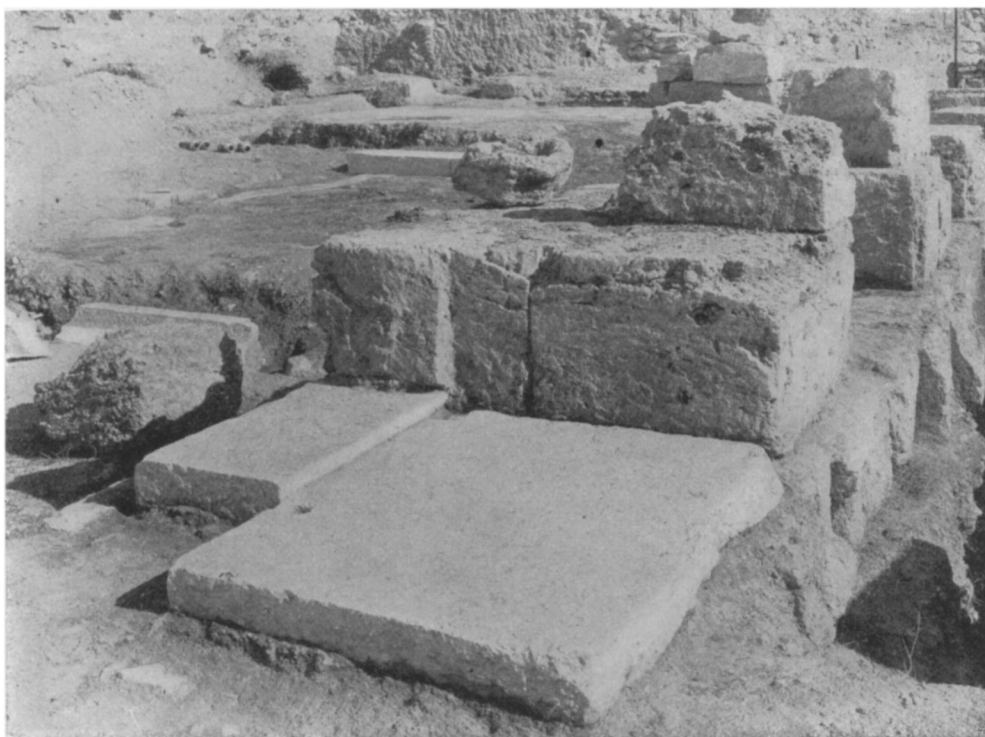
FIGURE 25. THRESHOLD IN NORTHEAST DOORWAY

The north wall was pierced by three entrances, a larger one in the centre and a smaller one on either side. The middle door had a width of 2.60 m. as measured by the length of the threshold. The latter is not preserved, but a rough cutting in the foundation shows its place and size. Thus the spacing of the piers was here different

from that in the rest of the wall, the space which formed the door having a width of 2.60 m. as compared with 1.45 m. elsewhere.

Of the two smaller entrances the eastern one is the better preserved, where part of the threshold is still left *in situ* (Fig. 25). The total width of the door was 2.09 m., hence considerably less than that of the main door but again wider than one of the regular spaces between the piers. The threshold, like those in the doors of the east wall (p. 45), was made of a hard cream-colored limestone. On the wall itself is a door jamb, 0.46 m. wide and projecting 0.11 m. Corresponding in width to the jamb was a raised part of the threshold, made of separate blocks. It projects 0.04 m. above the top of the wider blocks which covered the rest of the doorway. This lower part of the threshold had a width of 1 m. On the preserved block is a pivot hole in the corner and a smaller cutting near the west end of the block. The second cutting was made for fastening the

The northeast porch has disappeared but for one block of the foundation, which appears to be *in situ* (visible in figure 25 to the left of the threshold). The *poros* blocks were here laid in mortar on the rock, which was dressed down for this purpose. The cuttings show that the porch had a width of ca. 4 m. and a depth of ca. 2.30 m. The total width of the foundation is thus a little more than the distance between the outer corners of the middle pair of piers in the central porch. Of the west porch the concrete foundation remains, and this has approximately the same size as the rock dressing for the east porch. One would expect the northeast and northwest porches to have had only two piers each, spaced according to the width of the doorways; but the effect of these smaller porches having wider span than the middle span of the north central porch is most unhappy, and it is possible that some other solution was found. Since nothing has been discovered which can with certainty be assigned to the porches themselves, it would be futile to attempt a reconstruction based on the foundations alone.

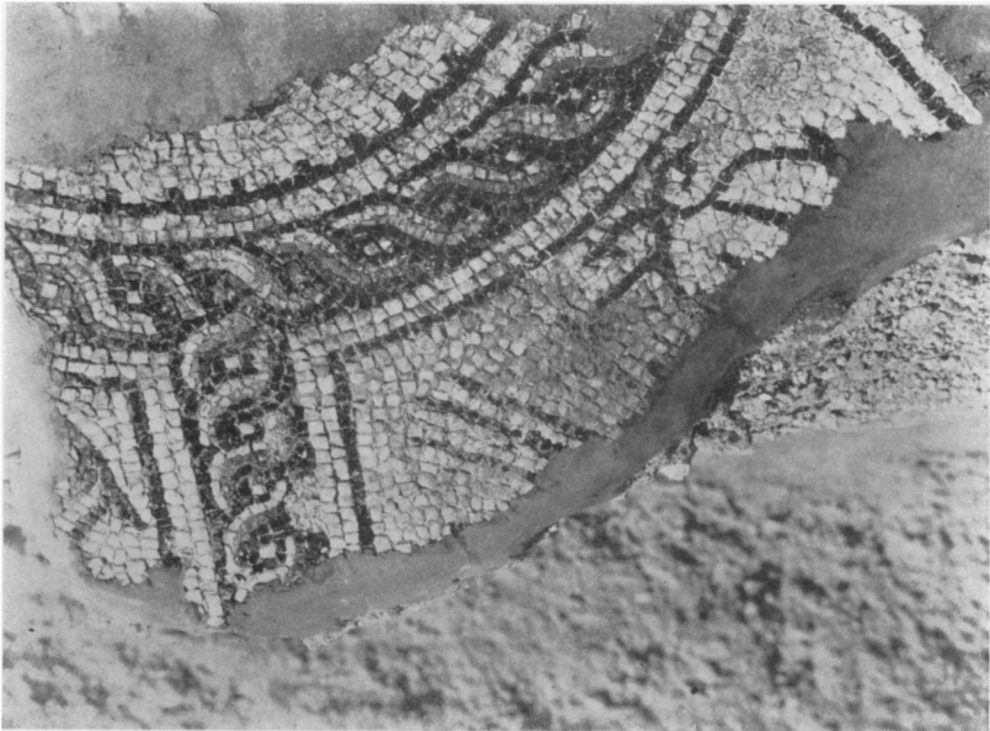
FIGURE 27. FRAGMENT OF MOSAIC FROM CEILING OF NORTH HALL

The north hall had a vaulted ceiling, of which large fragments were found in the fill above the floor. The vault was made of hard mortar, small stones, fragments of tiles, etc., forming a kind of *opus incertum*. The tiles, many of which are stamped, are of the same kind as those used for the water channel in the orchestra (see pp. 53 and 138).

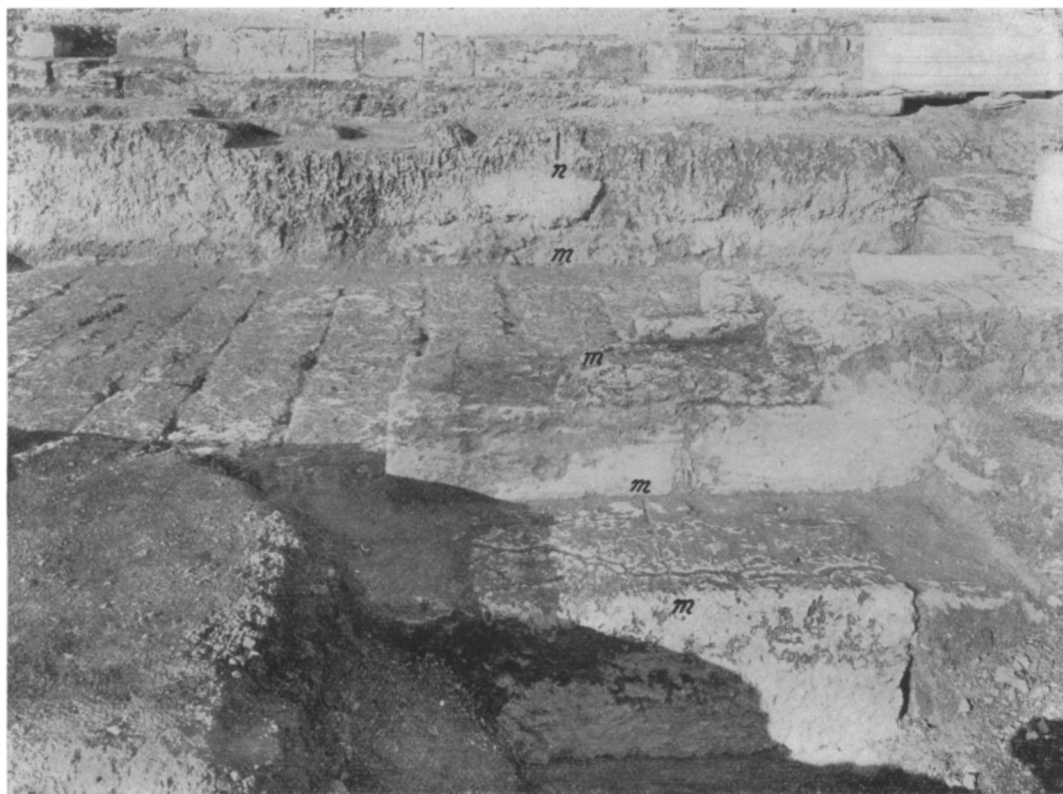
FIGURE 28. AXIAL LINE ON FOUNDATION OF SCAENAE FRONS

thickness over 5.50 m. The foundation for this wall from the very bottom is built of large *poros* blocks, which only in the upper courses were joined with wooden clamps. The foundation extends to a depth of ca. 3 m. below the orchestra floor and over 4 m. below the floor of the north hall. On this broad foundation rested the *scaenae frons*. On the top course of the foundation, in the exact axis of the scene-building, is a scratched line across the entire width of the foundation (PLATES II, III, and Fig. 28 *m-m*), and in the scarp of rock to the north of the wall is a small cutting (Fig. 28 *n*) directly above the line. Careful measurements show that this line if extended toward the north divides the scene-building exactly in the middle. The *cavea*, on the other hand, was less carefully laid out. If the same line is extended toward the south, it cuts the middle aisle not in the centre but close to its west edge. The axis of the *cavea* is marked on the top course of the foundation for the outer wall (PLATES II, III). The direction of the two lines, as has been pointed out above, is not the same. The difference is probably due to inaccuracy.
