CORINTH

VOLUME X

THE ODEUM

OSCAR BRONEER

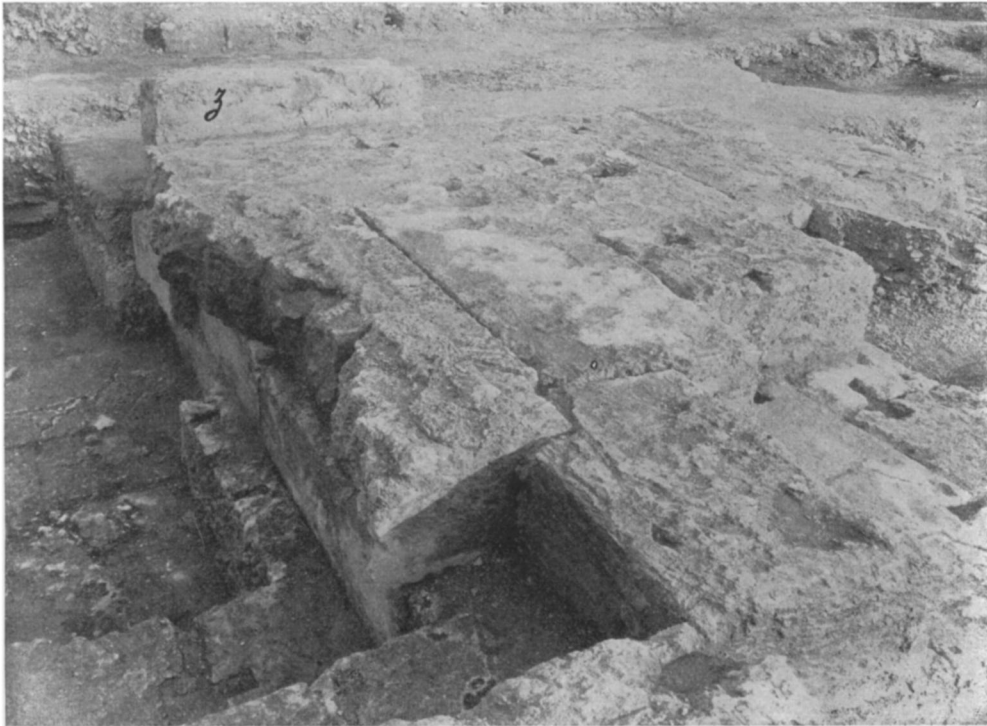
FIGURE 29. TRACES OF STAIRS, WEST OF STAGE

The foundation for the broad wall extended under rooms L and L' (PLATES II and III). Between room L' and the next room to the west (M') the distance is more than 3.50 m., which is too great for the thickness of a single wall in the interior of the building. In the north hall, 0.85 m. west of room L', is a rectangular piece of *opus incertum* built directly against the south wall (PLATES II, III *z*, VIII *z*, and Fig. 29 *z*). It measures 1.60×0.60 m., and its top is ca. 0.10 m. above the floor level of the north hall. From this structure two parallel walls of concrete extended toward the south. These walls were only 0.30 m. thick, and the distance between them is ca. 0.85 m. Between the walls near their north end are two shallow cuttings in the *poros* blocks. This puzzling construction of concrete, resting on the *poros* wall, was at first thought to be a modern wine press;² but a more careful study shows that it must belong to the first period of the Odeum. The mortar is exactly of the same kind as that used for the foundation of the building; and the

way in which the *poros* blocks on the west side have been broken away (PLATE II and Fig. 29) shows that at the time of their removal the concrete structure was already there and prevented further demolition of the walls at this point.

The two parallel walls are too thin to be partitions for a small room or closet, and the fact that they are of concrete indicates that they served some special purpose. They can only be the supporting walls for a stairway leading from the north hall to the second

story of the scene-building. The two shallow cuttings at the north end of the walls were made for holding in place the wooden beams supporting the form into which the concrete was poured. Similar cuttings are found in the floor of the semicircular corridor (see p. 24). The stairway must have extended from the north hall to the north wall of room N', where it opened into the second story; and in order not to make it too steep, an outside landing was made in the north hall so that the stairway could begin at the north face of the wall. This landing is the rectangular piece of concrete, on the top of which are traces of mortar bedding for a marble slab covering the concrete.

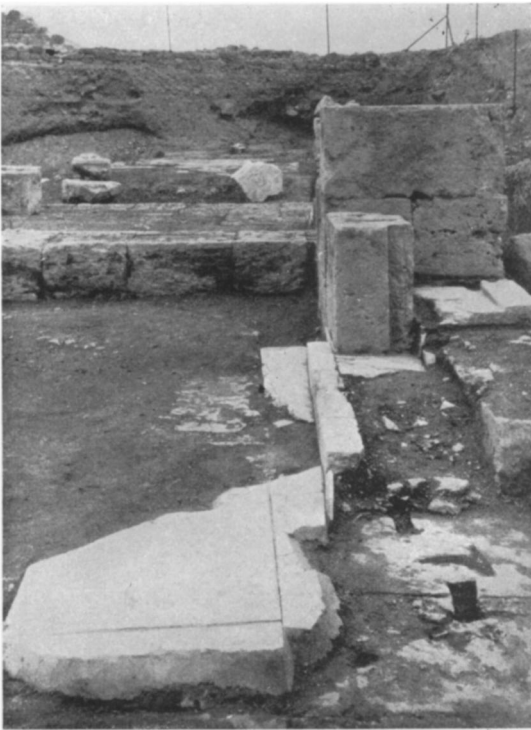
FIGURE 30. MARBLE FLOORING OF ROOM M,
EAST SIDE

wall extended from the north hall to the north wall of the *parodos*, forming the east wall of room M'. This and room M on the east side measured ca. 6.50 m. from north to south and ca. 8.50 m. from east to west. Room M is the better preserved. Its north wall is an extension of the broad wall, though here only 0.92 m. wide. The stones are joined by wooden clamps, but in the northeast corner of the room, where this wall is bonded into the east wall of the building, a few stones are fastened with leaded iron clamps (Fig. 24 and PLATE II). In room M the broad wall continues under the floor almost as far as the east wall (PLATES II, III, and Section I-J, PLATE V). Only two courses were laid, and on top of these is a fill of earth, 2 m. deep. The explanation for this apparent waste of material was given by the discovery of an early reservoir under the floor of the room (see p. 73).

side of the door (Figs. 30–32). The width of the door was then reduced to ca. 1.80 m. When this block was laid the old threshold was partly removed, but the part behind the block was left in its position.

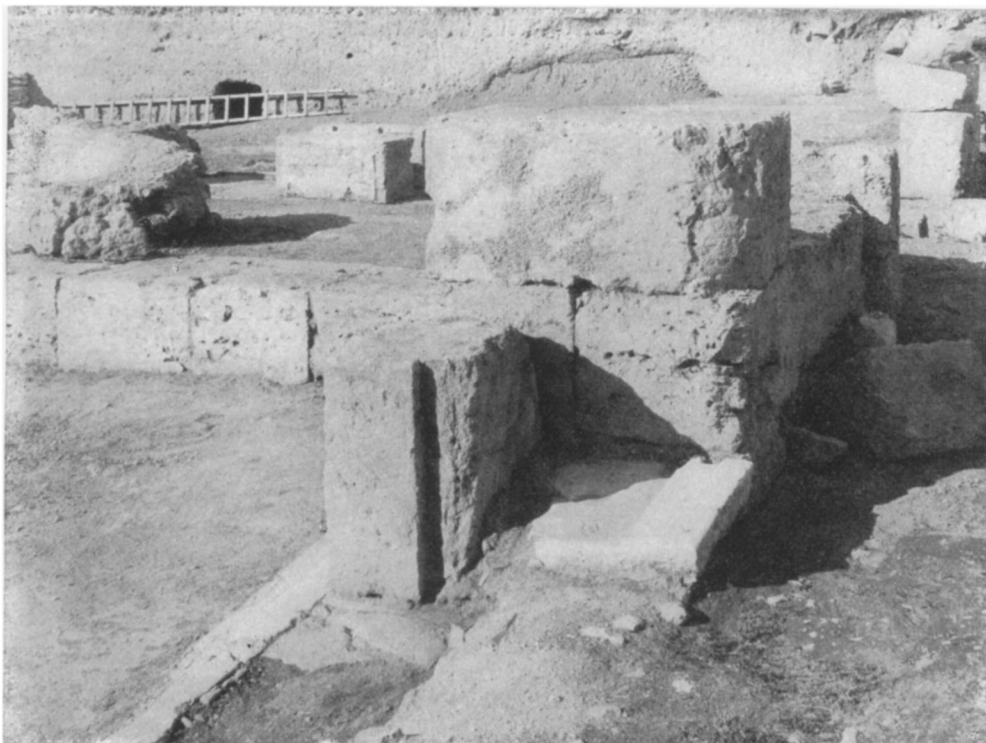
FIGURE 31. DOORWAY, EAST SIDE, SHOWING THRESHOLD BLOCK

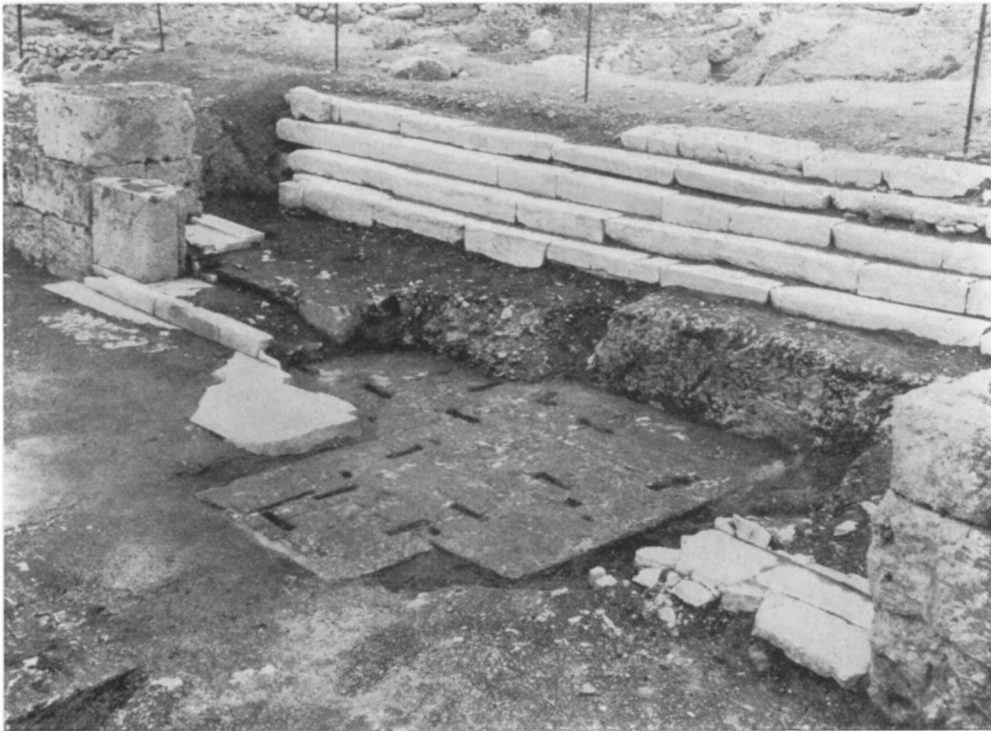
FIGURE 32. SOUTHEAST CORNER OF SCENE-BUILDING, SHOWING TWO DOORWAYS AND LONG MARBLE STEPS

Another doorway, ca. 2.30 m. wide, opens from the outside into the *parodos* at the east end of the semicircular corridor. This, too, had a threshold of hard limestone (Fig. 32, lower right corner), some pieces of which still remain *in situ*. In the southwest

From the doorway below the long marble steps (see p. 46 and Fig. 32, right) a low step leads down to the semicircular corridor, which here has the same level as the floor of room M. From this level there are three more steps (PLATE III and Fig. 33 p) down to the lower level of the *parodos*. At the inner ends of the *parodoi* are foundations for an ornamental doorway (PLATES I–III) with an inner width of ca. 1.30 m. Between this doorway and the semicircular corridor the *parodoi* were vaulted over, and the seats and

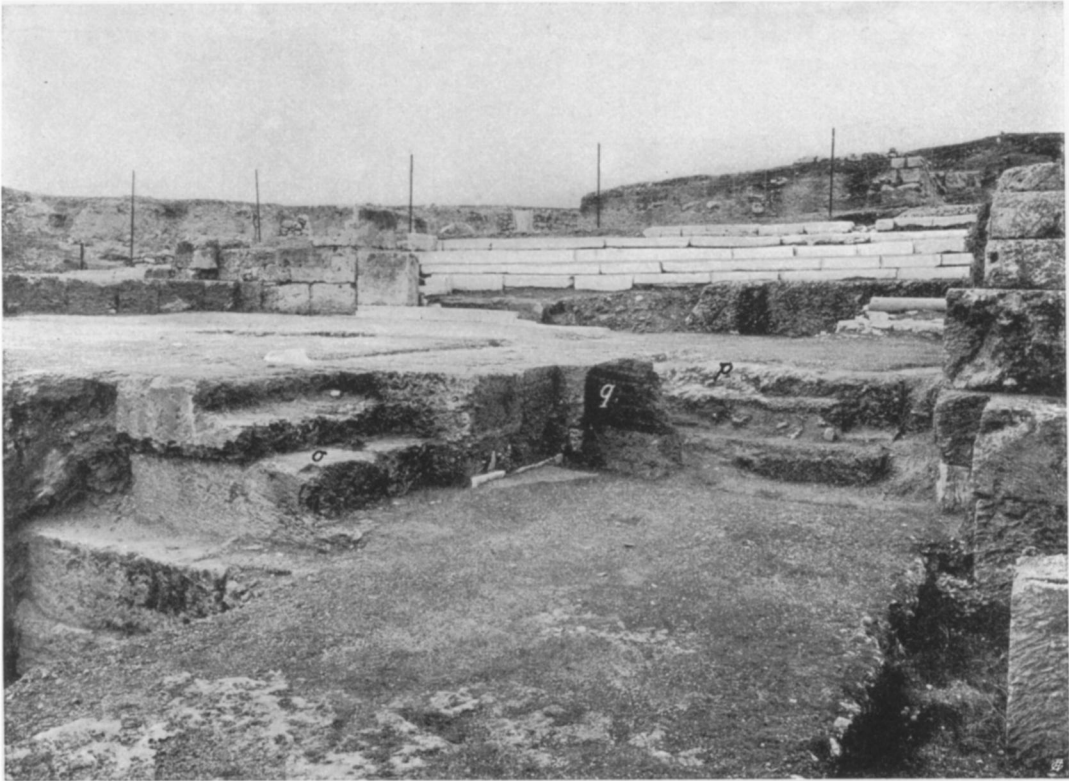
FIGURE 33. EAST END OF EAST PARODOS, SHOWING STEPS LEADING TO HIGHER FLOOR LEVEL

corner of room M three steps lead down into the *parodos* (Fig. 33 o), and small fragments of the marble veneer of a door jamb on the east side of the steps are preserved. But the steps were not made in the earliest period of the building. They are cut roughly through the stones in such a way as to show that they were not intended from the beginning.

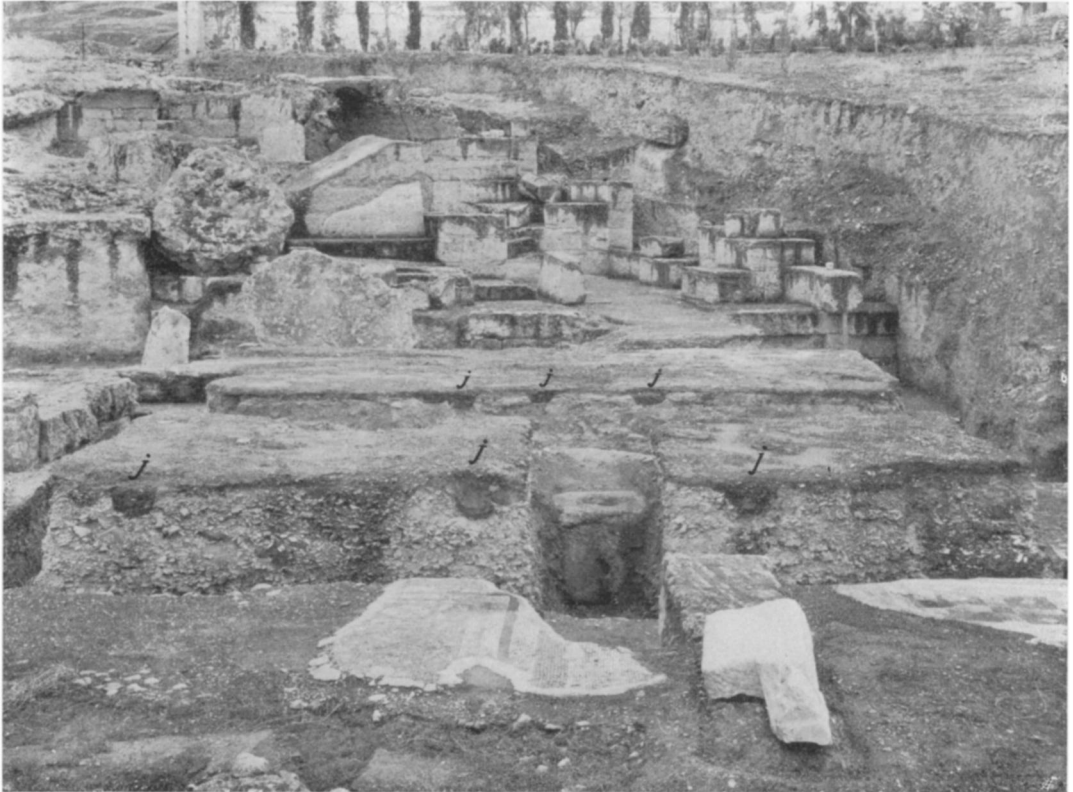
FIGURE 34. FLOORS OF ROOM M' AND OF NORTH HALL, WEST END, SHOWING DEPRESSIONS FROM WATER JARS

clay, into which were set several earthen jars, later removed or broken off flush with the floor and the holes filled with clay (Fig. 34 j). In the fill under this early floor is a layer of marble chips and burned matter. This seems to date from a fire which partly destroyed the building while still under construction, and it also proves that marble was used to some extent in the first period. Above the clay floor are traces of the mortar bedding for the marble slabs, which here, too, in the second period covered the floor. Near the east wall of the room is a large *poros* block with a square cutting roughly corresponding to the westernmost of the two blocks in room M. There is another hole in the floor farther west, but this seems to have been made in the clay by one of the earthen jars already mentioned.

the stage, and a corresponding door may be postulated for the east room. The purpose of the water jars in the floor of room M' is not evident. The western part of the north hall had a floor made of the same kind of dark clay, and there, too, the water jars are present (Fig. 34 j). Whatever their purpose they can have been of no permanent use, since they were destroyed when the floor was made. Apparently they were used only during construction, perhaps for making mortar or for the painting of the walls.

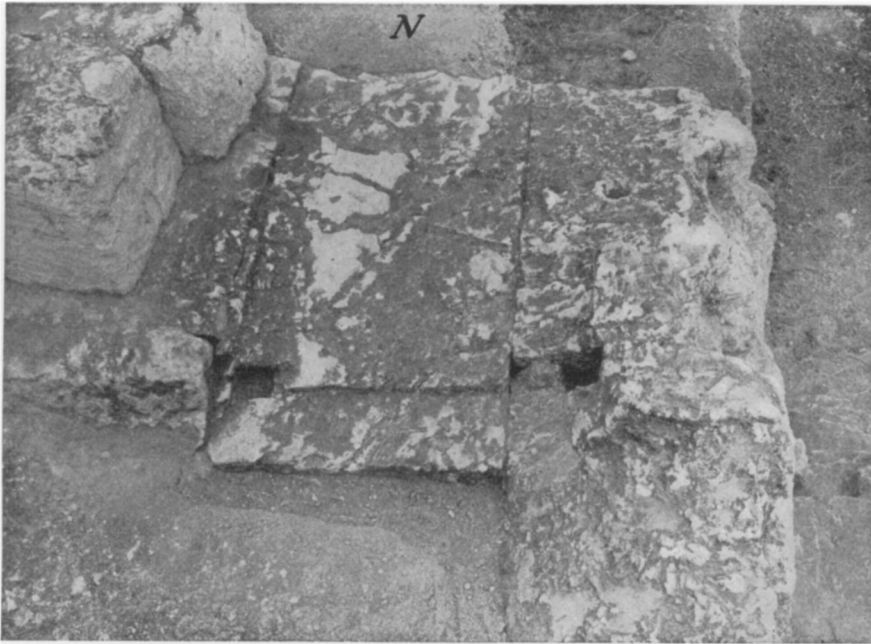
FIGURE 35. TRACES OF THE DOOR BETWEEN ROOM N AND THE ARENA

and M', between which and the stage the communication led through rooms N and N'. Hence there must have been a door at each end of the stage (the *versurae*) which led into these small rooms. In the last period the thresholds of these doors were lowered and strong doors opening directly into the arena were inserted, the pivot holes and bolt holes of which can still be seen (Figs. 35 and 36). At the same time the floor level was lowered, but this was done in a rough way leaving it higher round the edges (see Section G-H, PLATE IV). In room N the floor at this period consisted of the natural soft rock hollowed out in the middle in a cave-like fashion. Since these rooms opened directly on to the arena, from which they could be closed off by strong doors, and since there are no other rooms that could be used as cages for the wild beasts employed in the performances, we may assume that rooms N and N' were so used.

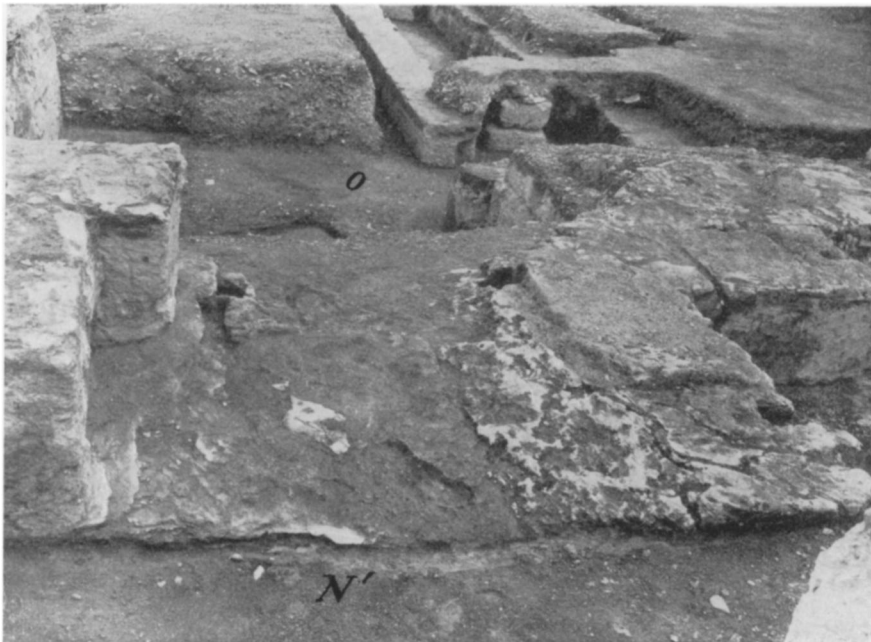
FIGURE 36. TRACES OF THE DOOR BETWEEN ROOM N' AND THE ARENA

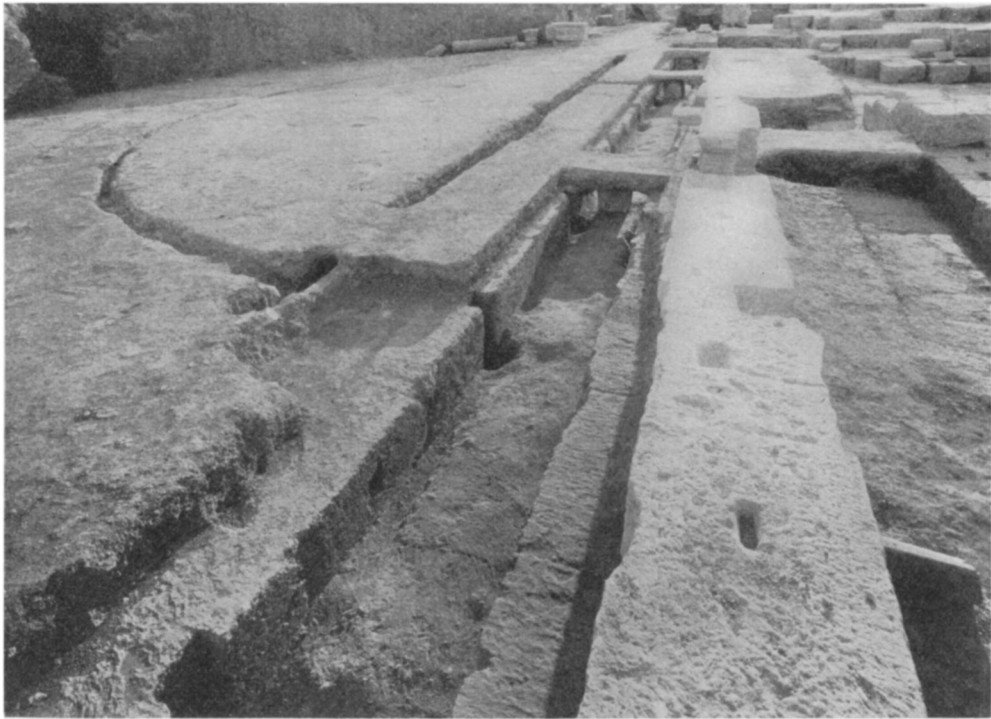
FIGURE 38. CURTAIN CHANNEL FROM THE EAST

wall on which the *scaenae frons* rested. Thus all traces of the former stage were hidden. But during the course of the excavation it became evident that the arena floor concealed much that belonged to this former stage. The most important part is the curtain channel, 23.40 m. long and 0.85–0.88 m. wide, continuing the line of the north walls of the two *parodoi* (Sections A–B and C–D, PLATE IV, and Fig. 38). The walls of the channel, which are preserved only in their lower course, rest directly on the earth or soft rock. In the edge of the wall toward the orchestra are eight vertical cuttings, 0.24–0.27 m. wide and continued some 80 cm. into the rock below the bottom of the channel. The mean distance between the cuttings is 2.91 m., not counting the two spaces at the ends. The

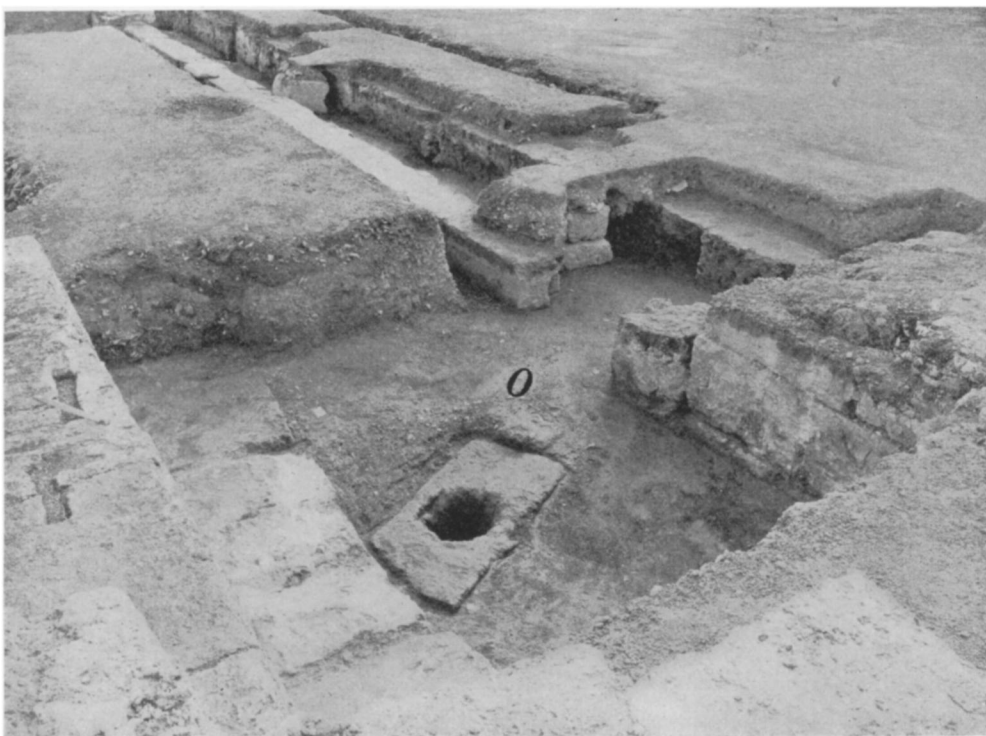
FIGURE 39. WEST END OF CURTAIN CHANNEL AND ADJOINING ROOM O

variation is very slight. At the west end are two shallow cuttings in the upper edge of the walls, directly opposite each other, probably made for the insertion of a cross piece of wood. At a distance of 0.65 m. from the west end, an opening 0.80 m. wide in the north wall of the channel leads into a small rectangular room measuring 3.20×2.70 m. (marked O on PLATE III and in Fig. 39), the floor of which is level with the bottom of the channel. When the stage was in use, its height above the orchestra—which, as we shall see later, was ca. 1.25 m.—afforded sufficient space for a man to walk upright in the curtain channel and in the adjoining room O. A *poros* block, measuring 1.25×0.60 m.,

with a square cutting in the middle, is sunk into the floor. The cutting, which is ca. 0.23 m. square and 0.42 m. deep, is very nearly in the centre of the room.¹

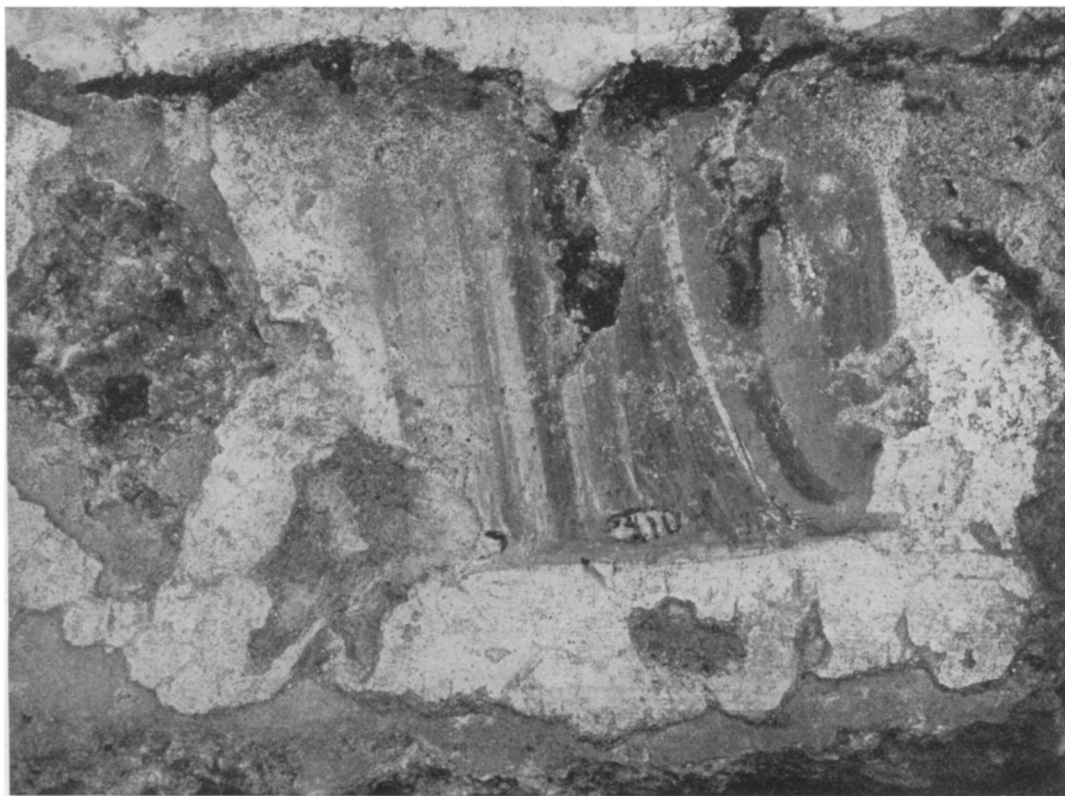
FIGURE 40. RE-USED BLOCK WITH FIGURE OF ATHENA

study of the figure of Athena.¹ But the other fragment with the painted column is most closely related to the fourth style of Pompeian wall painting. On the other hand, the kind of stucco used, as well as the tooling, shows beyond doubt that the material was first used in a Greek building. The hard, thin coat of stucco found on many of the blocks is typically Greek, whereas the thick coat on which the paintings were executed is Roman.² These two kinds of stucco are found in other Greek buildings in Corinth

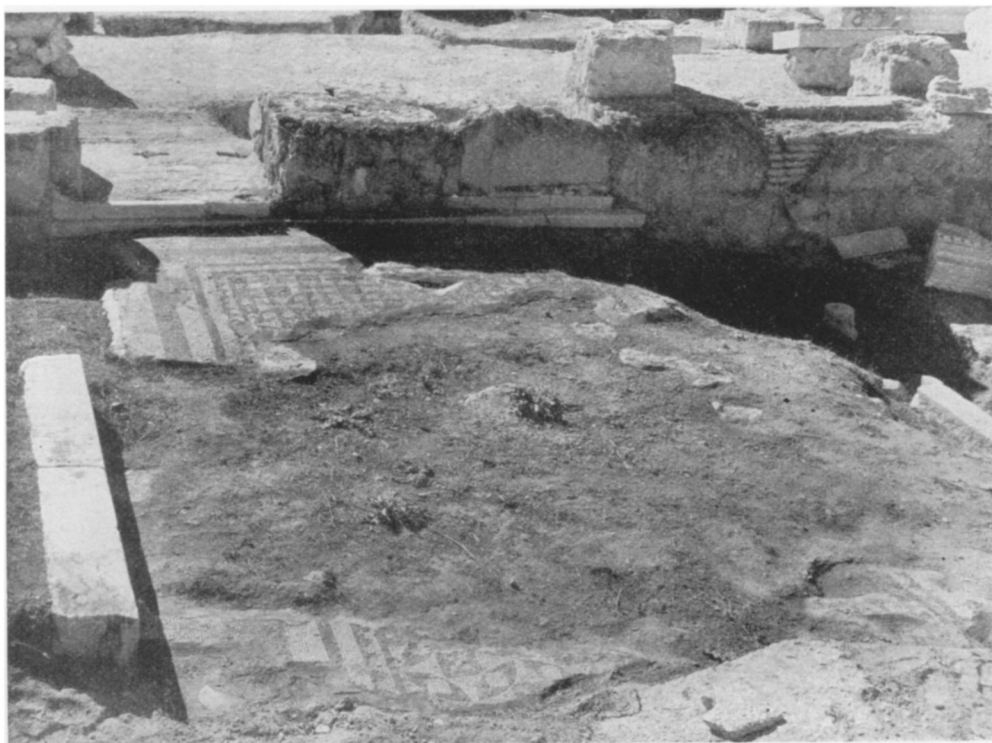
FIGURE 41. MOSAICS OF COLONNADE ON EAST SIDE OF ODEUM COURT

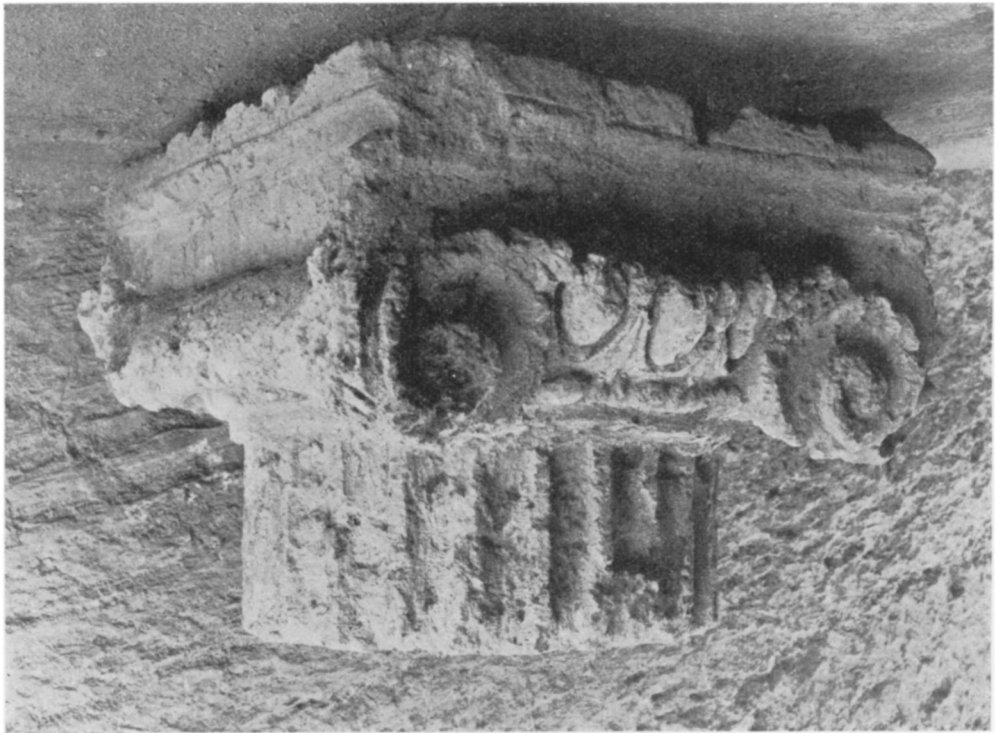
FIGURE 48. IONIC CAPITAL OF POROS (2)

2. Figs. 48 and 49. Ionic column capital of *poros*, found in the semicircular corridor close to the niche between piers 13' and 14'. The carving is deep but carelessly done, and over it was a thick coat of white stucco. The capital is certainly Roman, but it is difficult to assign it to the Odeum. The large size (see dimensions in Fig. 49) makes it impossible to connect it with an inner colonnade round the upper part of the cavea, and it is improbable that it was used in connection with the stairway on the south side. A pit dug south of the modern road revealed part of a foundation for a large building, ca. 15 m. south of the Odeum. This was probably a stoa, and it is not unlikely that the capital belonged to it.

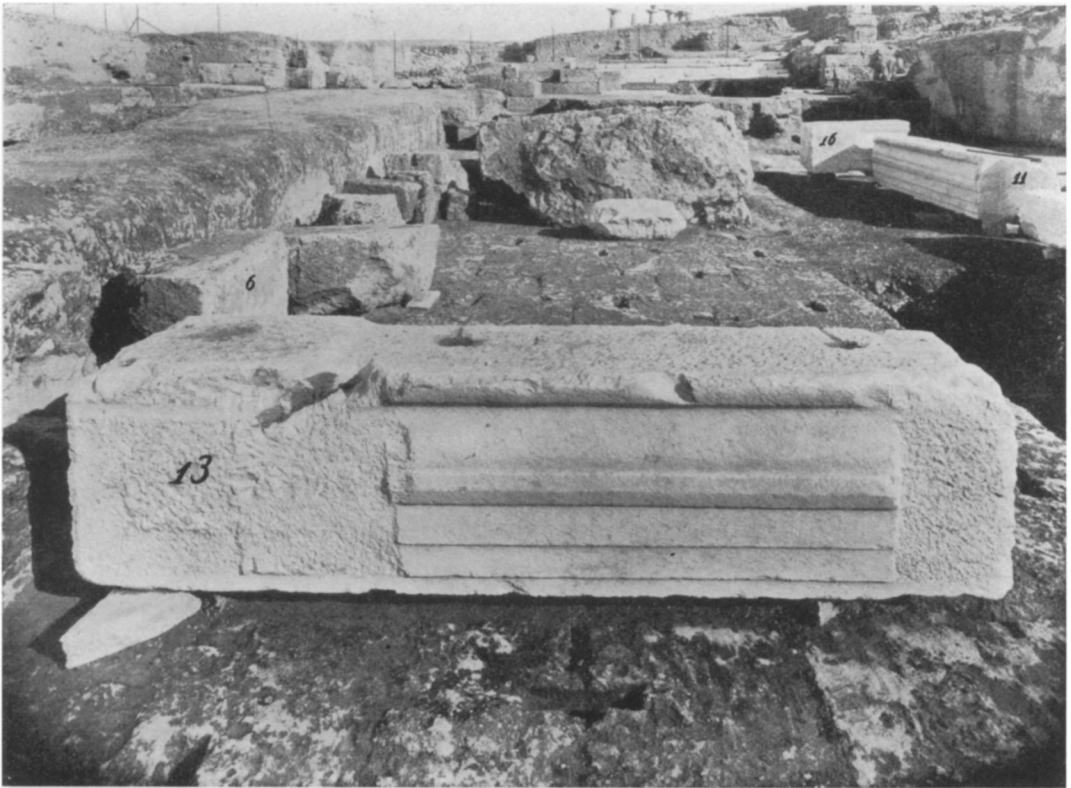
FIGURE 64. REAR FACE OF BLOCK 13

13. Figs. 59, 63 and 64. Architrave and frieze of white marble, found near the middle of the foundation for the *scaenae frons*. The profile is the same as that of the preceding two blocks. The top was cut down 0.04 m. at the time when the block was re-used, but the original surface was left in a narrow strip along the back and at the right end (Fig. 63 a, c, and Fig. 64). On the lower surface are two square dowel holes with pour channels, and a narrow dowel hole which, however, must have belonged to the first period of the block, since in its present form it is too shallow to be of use. At each end are two cuttings for clamps running lengthwise with the block. The left end had a third clamp at right angles to the block. A larger clamp cutting, 0.25 m. from the same end, is later than the others. The back is shown in figure 64. Here the face has been cut back at both ends to the plane of the lowest fascia. The cutting at the right end, as seen in figure 63 b, is more than twice as long as that at the left end and appears to have been cut back twice (see Fig. 64, where the left end of the block is the same as the right end in Fig. 63). Near the inner end of the cutting is a hole for a clamp at right angles to the block. These later cuttings are so badly executed as to be all but

useless as hints for the placing of the block in the building. The clamp cuttings at the ends and the *anathyrosis* seem to show that the block is preserved in its original length, which is 2.615 m., measured on the front face.

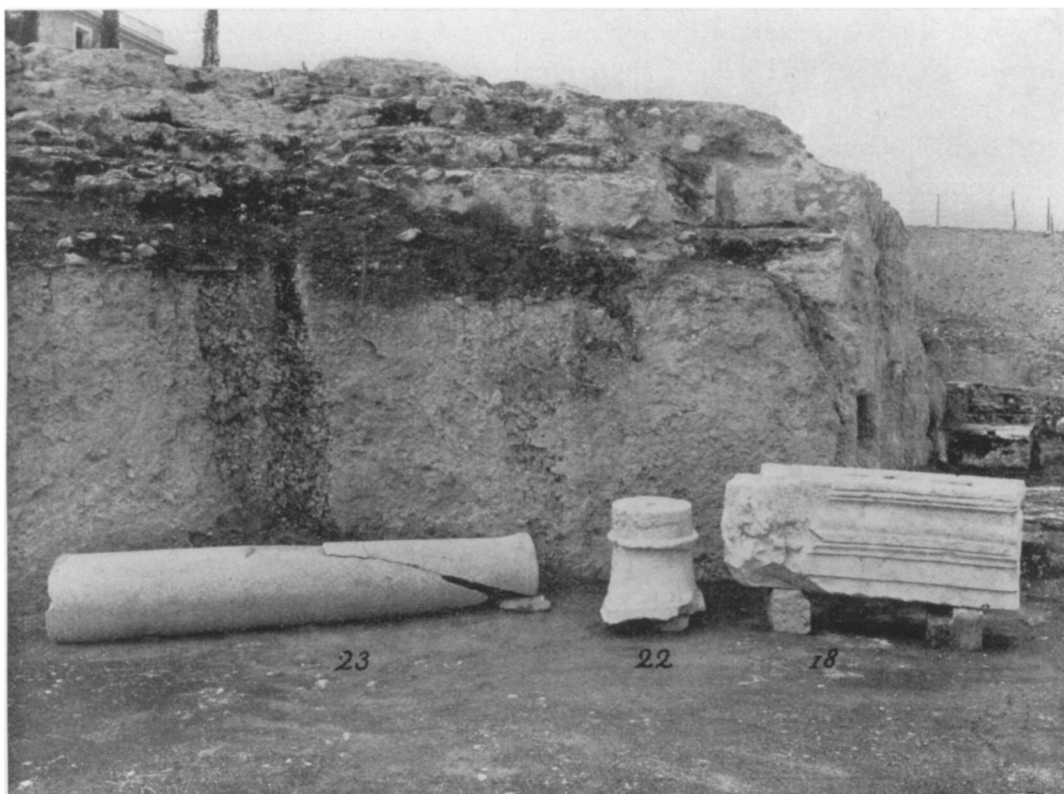
FIGURE 70. ARCHITECTURAL MEMBERS FOUND NEAR WEST PARODOS

18. Figs. 69 and 70. Architrave and frieze block of white marble, found at the east end of the west *parodos*. The profile resembles that of blocks 16 and 17, but the moulding above the frieze consists of a simple astragal between two flat bands, corresponding to the small *cyma recta* of the other two blocks, and the whole block is more carefully cut. Face *a* is finished from the left end for a distance of 0.80 m. at the top and ca. 0.70 m. at the bottom. Beyond this finished surface the whole face of the block is divided into five fasciae, and close to the end is a vertical groove continued by a similar groove in the top. The finished face is straight, but the part with the five fasciae is convex. The opposite side, shown in figure 70, has a uniform curve parallel to the curve on the other side (Fig. 69 *b*). At the

22. Figs. 70 and 74. Corinthian capital of white marble found at the east end of the west *parodos*. The lower part has a single row of acanthus leaves, and above is

a series of pointed leaves covering the bell.¹ Only one half is properly finished (Fig. 74 a and b, and Fig. 70); on the other side the leaves are merely indicated on the surface. The finished half cuts the abacus diagonally as indicated in figure 74 a, which shows that the capital was intended to be seen from the corner. Further-

23. Fig. 70. Shaft of a granite column, found near the east end of the west *parodos*. The lower part is missing and the top is broken away, but the broken end was found with the column. The diameter at the top measures 0.46 m. including the moulding, below the moulding 0.41 m., and at the broken lower end 0.46 m.

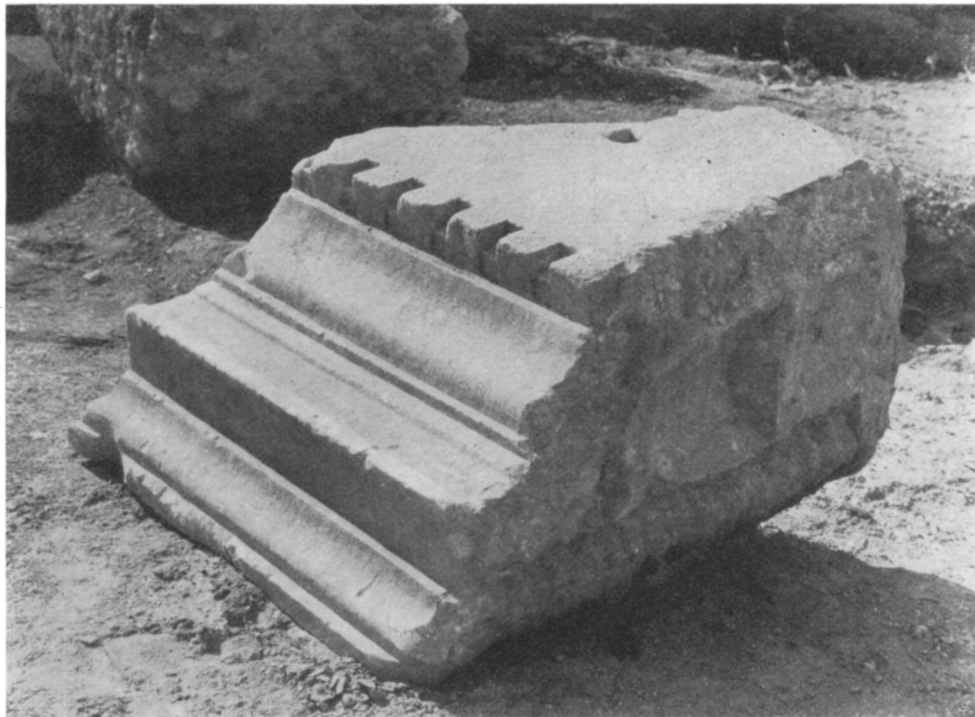
FIGURE 75. FRAGMENT OF CORNICE (24)

24. Fig. 75. Fragment of marble cornice found near the northeast porch. Total height 0.36 m.; width 0.68 m.; length of fragment 0.70 m.; projection of corona from dentils 0.194 m.; total projection from dentils to topmost taenia 0.258 m. The upper part of the via is not cut back to the full depth of the dentils. The carving is carefully done.
25. Fig. 76. Upper part of Ionic cornice with the corner preserved, found on the north side of the scene-building. Height of fragment 0.207 m.; length 0.48 m.
26. Fig. 77. Fragment of Ionic cornice with large dentils. At the corner is a bud. Length of fragment 0.62 m.
27. Fig. 78. Elaborately carved fragment of cornice found at the north side of the scene-building. Above the dentils runs a Lesbian leaf. The under side of the

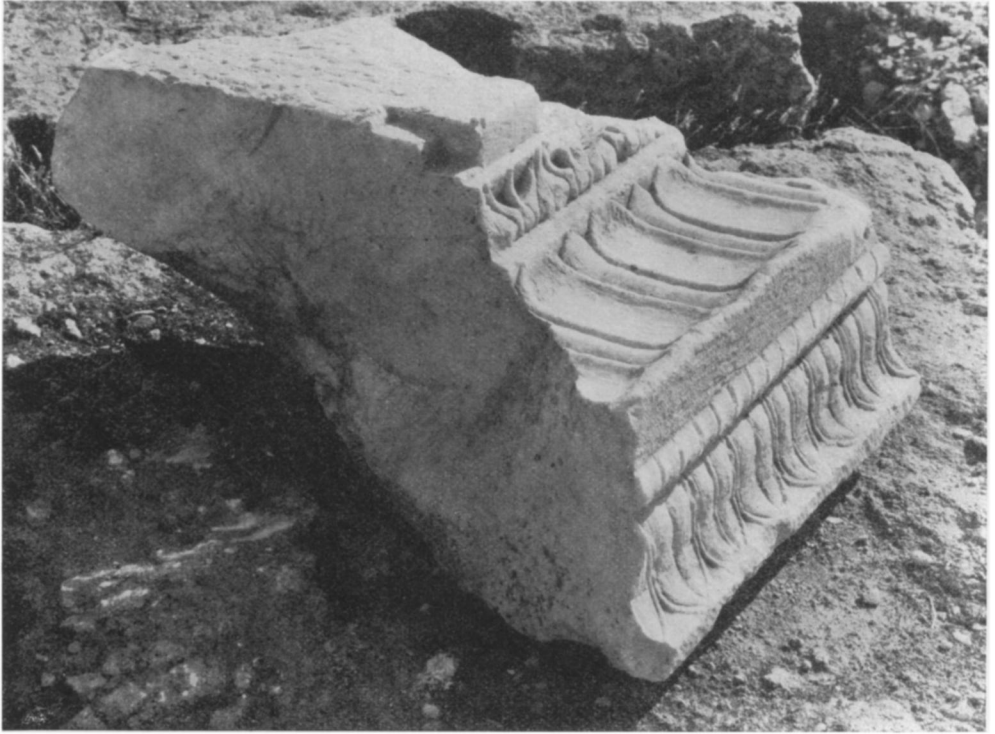
FIGURE 78. FRAGMENT OF CORNICE (27)

corona is decorated with a tongue-and-dart pattern, and the *cyma recta* at the top has a design of pointed leaves above an astragal with a cable pattern. The carving is poor. Length of fragment 0.38 m.; width 0.57 m.; total height 0.277 m.; total projection from dentils to topmost band 0.225 m.

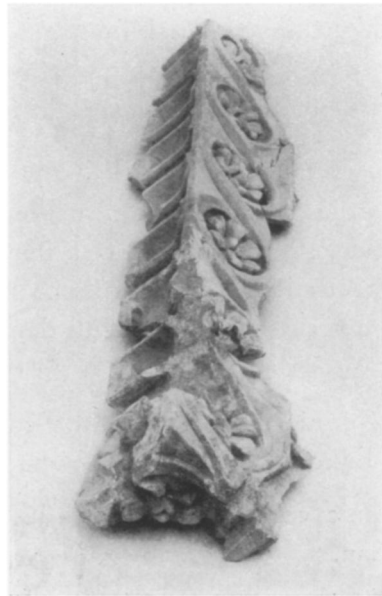
FIGURE 79. FRAGMENT OF CORNICE (28)

28. Fig. 79. Small corner fragment of cornice found in the curtain channel. The front face of the corona is decorated with rosettes enclosed within the loops of interconnected S-shaped designs; on the under surface there is a pattern of broad

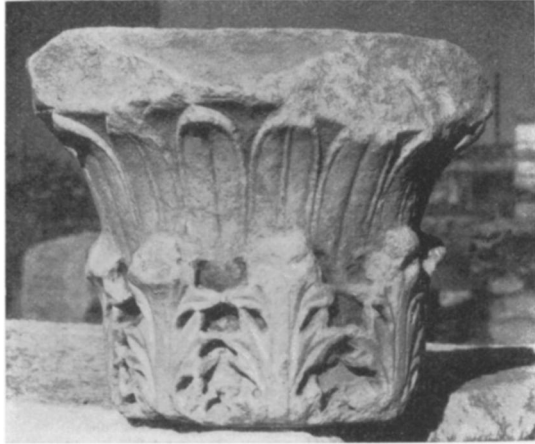
FIGURE 84. SMALL CORINTHIAN CAPITAL (33)

33. Fig. 84. Small capital of the same general type as No. 22, figure 74, found near the northeast porch. Lower diameter 0.195 m.; width of abacus 0.305 m.; total height 0.235 m.
34. Fig. 85. Corner volute of Corinthian capital from the débris of the Odeum of Herodes Atticus.

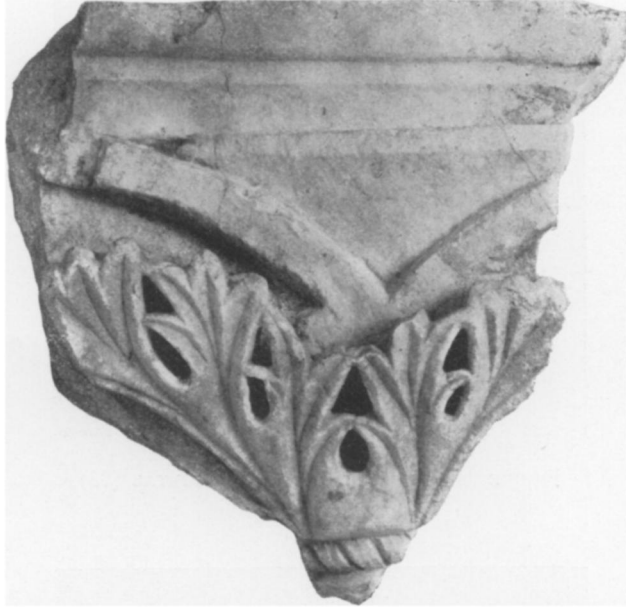
FIGURE 87. FRAGMENT OF PILASTER CAPITAL (37)

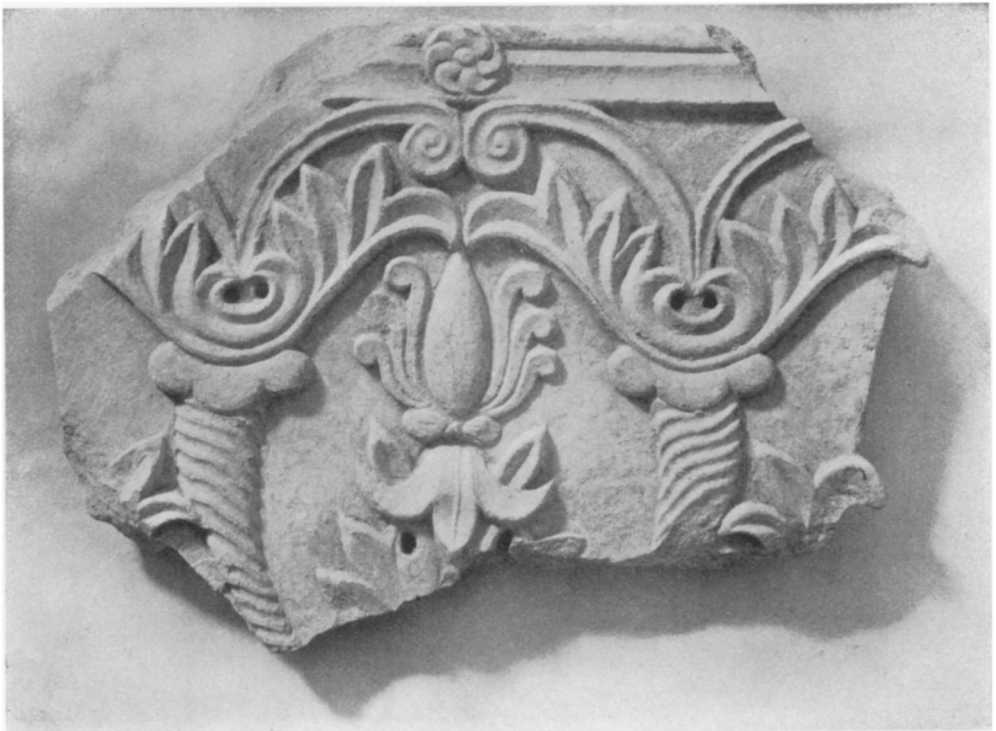
FIGURE 88. FRAGMENT OF PILASTER CAPITAL (38)

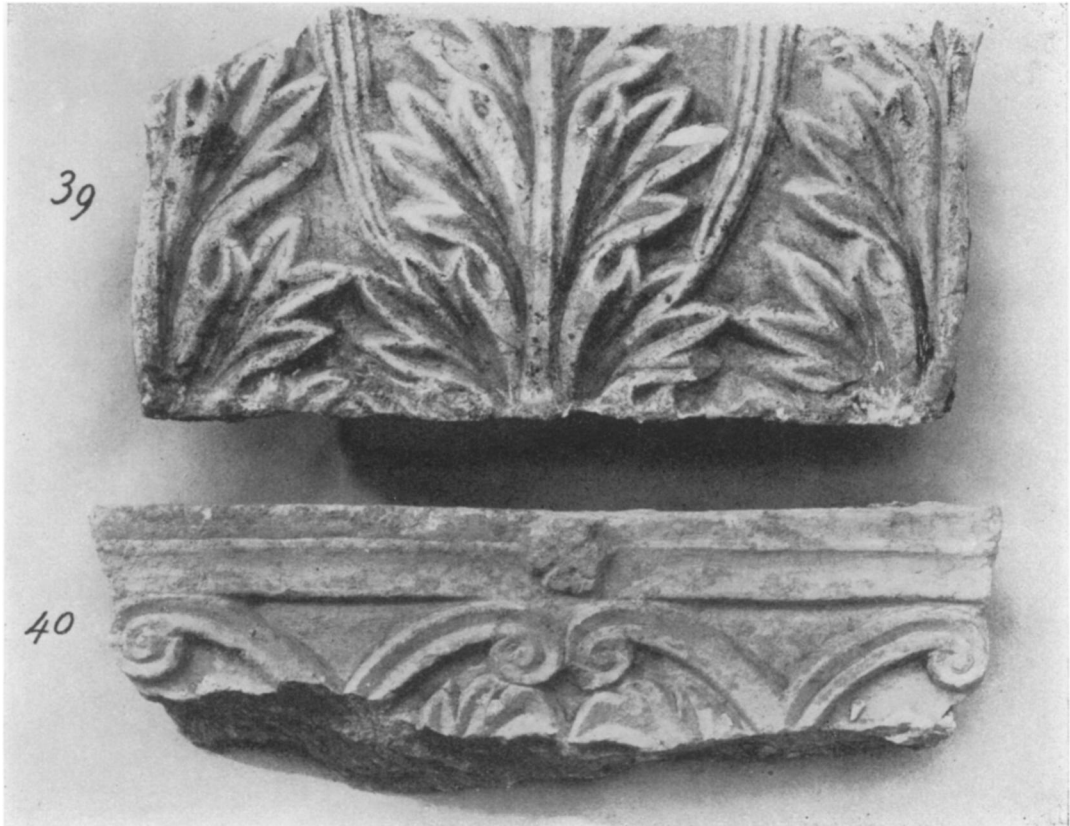
FIGURE 89. FRAGMENTS OF PILASTER CAPITALS

37. Fig. 87. Fragment of large pilaster capital. Width of fragment 0.36 m.; height of fragment 0.33 m.; greatest thickness ca. 0.14 m.
38. Fig. 88. Upper part of pilaster capital found in fill about *poros* block in floor Q (p. 68). Width of fragment 0.315 m.; height 0.23 m.; greatest thickness ca. 0.04 m.
39. Fig. 89. Lower part of pilaster capital found below the long marble steps east side of the building. Width at the bottom 0.26 m.; height of fragment 0.13 m.; greatest thickness 0.022 m.
40. Fig. 89. Upper part of pilaster capital found with No. 38, figure 88. Width at the top 0.285 m.; height of fragment 0.075 m.; greatest thickness 0.048 m.

83–88. Fig. 103. Fragment 83 has on the front face the head of a bull in relief, perhaps the decoration on the middle piece of an arch; No. 84 is part of a pilaster capital (cf. Fig. 89); No. 85 has a melon-shaped decoration resembling that on No. 26

These queer figures probably decorated some part of the stage or the *scaenae frons*, but exactly what part is difficult to determine. One might suppose that they belonged to the decoration of a ceiling; but if that were the case, some fragment of the frames round the figures would doubtless be preserved. It is more likely that the slabs were used as decorations on the socle below the first row of columns. No slabs of this kind were found in the Odeum itself. The work is very careless, and it is evident that the architect did not treat these slabs as sculptured reliefs, but used the faces merely as patterns for the decoration of architectural members. The carving is not unlike that on some of the pilaster capitals (Figs. 88 and 89).

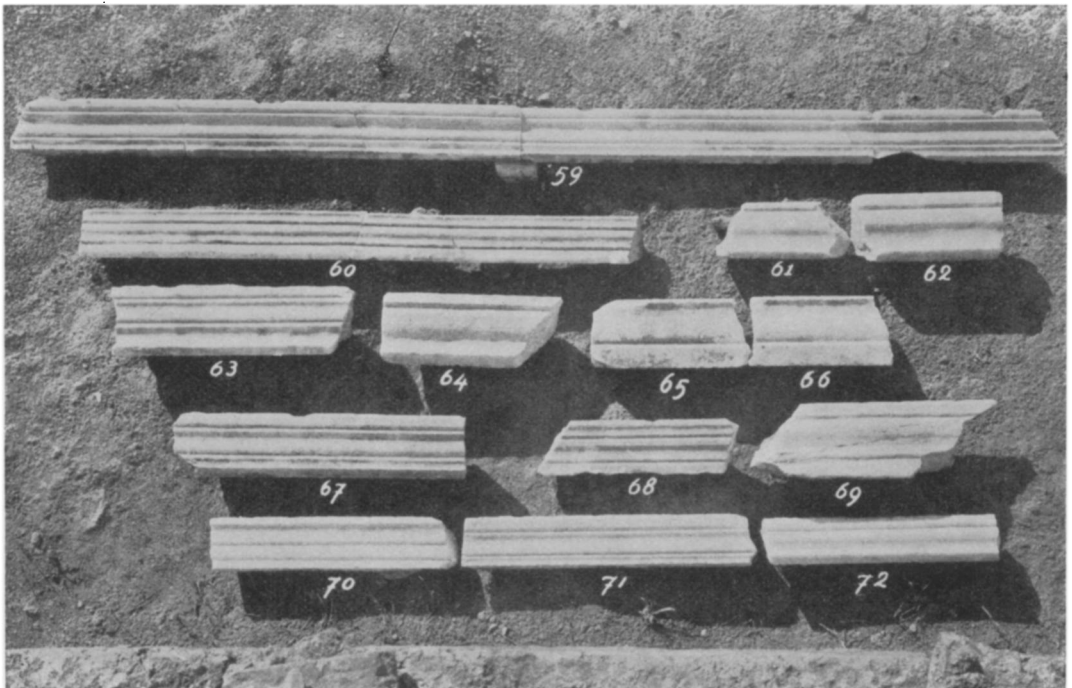
FIGURE 93. BASE MOULDINGS (59-72)

59–72. Fig. 93. Fragments of base mouldings of various sizes. Large numbers of similar mouldings were found in various parts of the building, most of them in the man-hole under the north central porch.

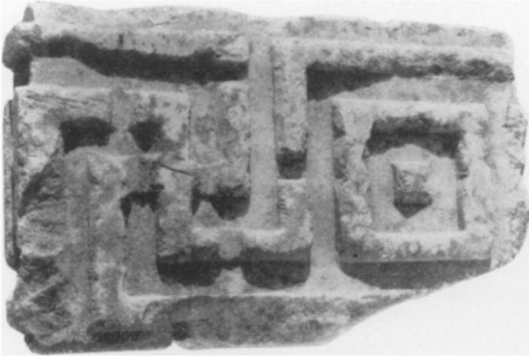
FIGURE 94. MOULDING WITH MEANDER PATTERN (73)

73. Fig. 94. Corner piece of meander moulding. Height 0.195 m.; thickness 0.072 m.; length of fragment 0.325 m.
74. Fig. 95. End piece of moulding with a simple guilloche pattern; above a bead-and-reel. Total height 0.14 m.; thickness at the bottom 0.17 m.; length of fragment 0.31 m. The cutting at the bottom seems to be a repair.

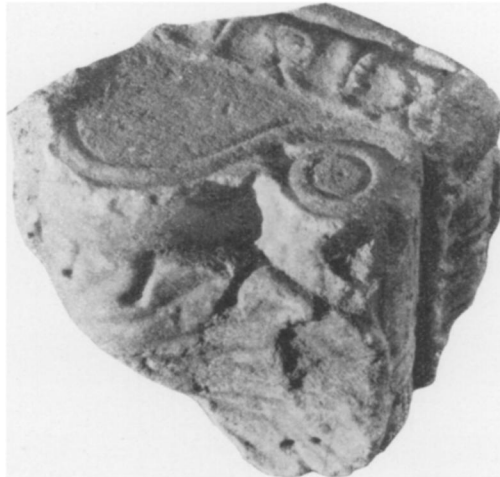
FIGURE 96. FRAGMENT OF CONSOLE (75)

75. Fig. 96. Fragment of console or modillion with broad acanthus leaf underneath. Original width ca. 0.095 m.; original length ca. 0.135 m.
76. Figs. 97 and 98. Top piece of pedestal, one half found near the west end of the curtain channel, the other half in room O. It is much damaged by fire and cracked in several places. The material is white marble. On three sides are

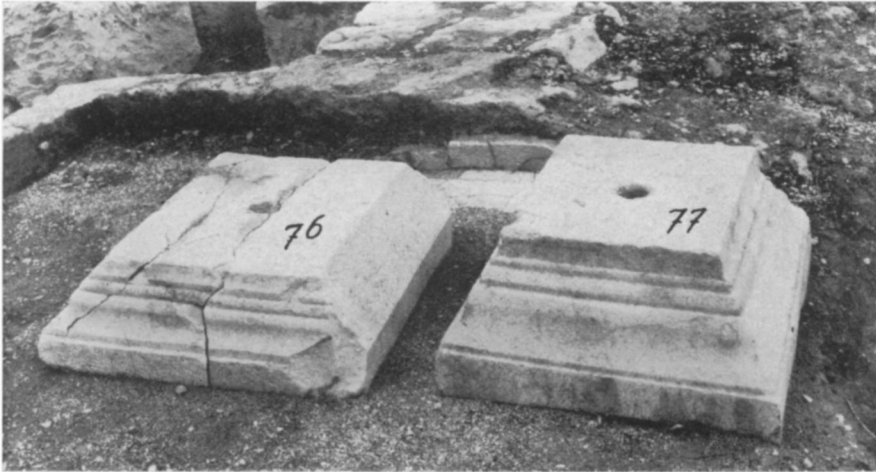
FIGURE 97. TWO STATUE BASES, BOTTOM

carefully cut mouldings, but the fourth side is merely bevelled off at the bottom. In the centre of the bottom (Fig. 97) is a circular dowel hole. The top (Fig. 98) has two oval cuttings, ca. 0.05 m. deep. Round one of these cuttings the surface of the stone has been cut down in the shape of a human foot. There is no corresponding cutting for the other foot, which must have rested directly on the top of the block. The cutting for the foot is 0.30 m. long. The statue supported by the base was of bronze with the weight on the right foot, the left knee bent, and the left foot dowelled to, but not set into, the base.¹ Length 0.59 m.; width 0.518 m.; height 0.17 m.

77. Figs. 97 and 98. Top block of pedestal found in room O. The material is limestone, like that used for the thresholds of the building. It has suffered less from

the fire than the preceding block. It is finished with a profile on all four sides. In the centre of the bottom (Fig. 97) is a circular dowel hole. The top (Fig. 98) has two sets of dowel holes, indicating that the base was used twice. The three smaller holes which are almost circular belong to the original use of the base. In front of the two holes near the middle, the surface has been slightly cut down. The holes are for two dowels from the heels of a bronze statue which was further supported by a staff or some other object held in the right hand. The right foot was slightly advanced, but both feet rested flat on the base. The cuttings would fit a statue having the pose of the Herakles statuette in Boston.² The two larger cuttings near the edges must belong to a later use of the base. Length 0.545 m.; width 0.47 m.; height 0.225 m.

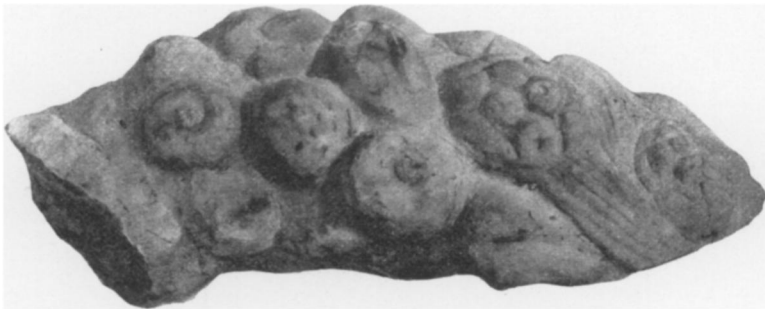
FIGURE 99. FRAGMENT OF GARLAND (78)

78. Fig. 99. Small fragment of garland of white marble. Rather poor, careless carving. Length of fragment 0.32 m.

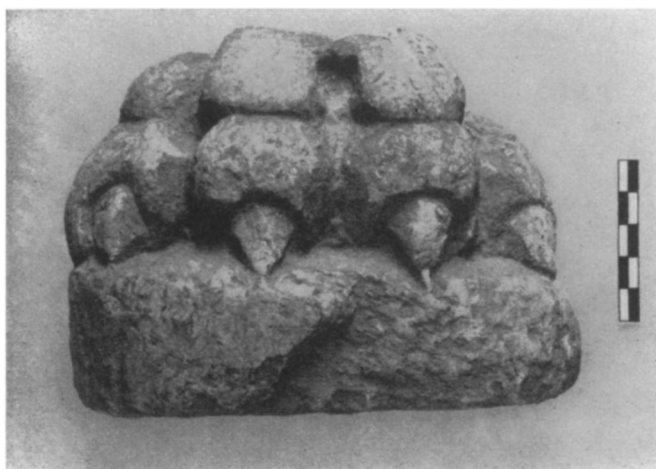
FIGURE 102. FRAGMENT OF LION'S PAW (82)

81. Fig. 101. Marble slab carved on two sides and on the top. One side, as seen in section *a-b*, is curved, the other straight. The carving is most carefully done and the surface has been highly polished. It is probably part of a balustrade, but the curvature is puzzling. It was found at the northwest corner of the Odeum, and it is not certain whether it belongs to the building.
82. Fig. 102. Part of a lion's paw of cream-colored marble found in the orchestra. It probably belonged to the supports for one of the seats in the *proedria*.
