CORINTH

VOLUME X

THE ODEUM

OSCAR BRONEER

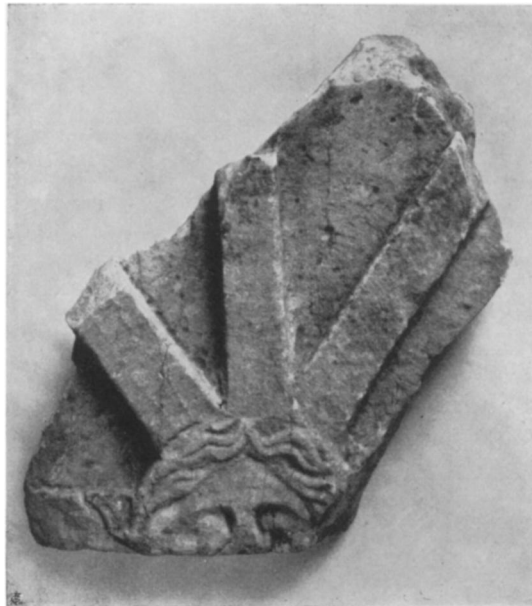
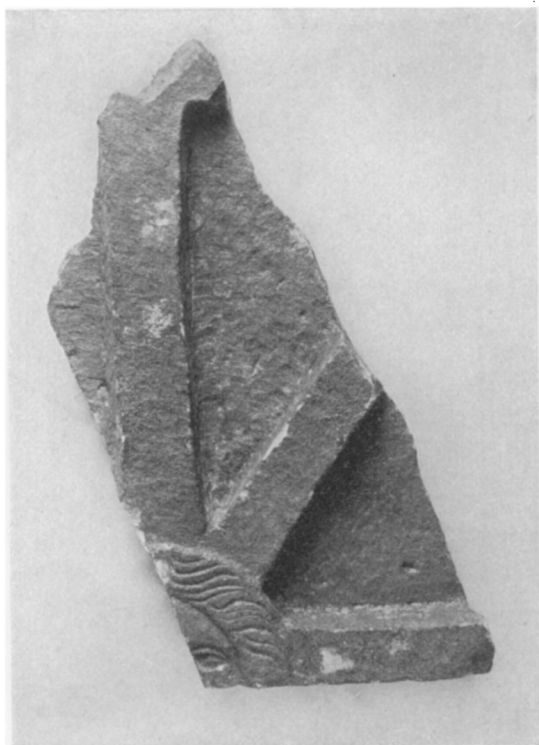
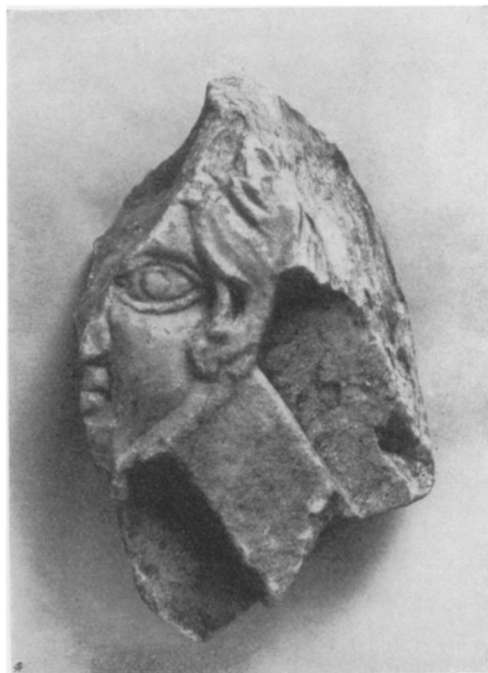
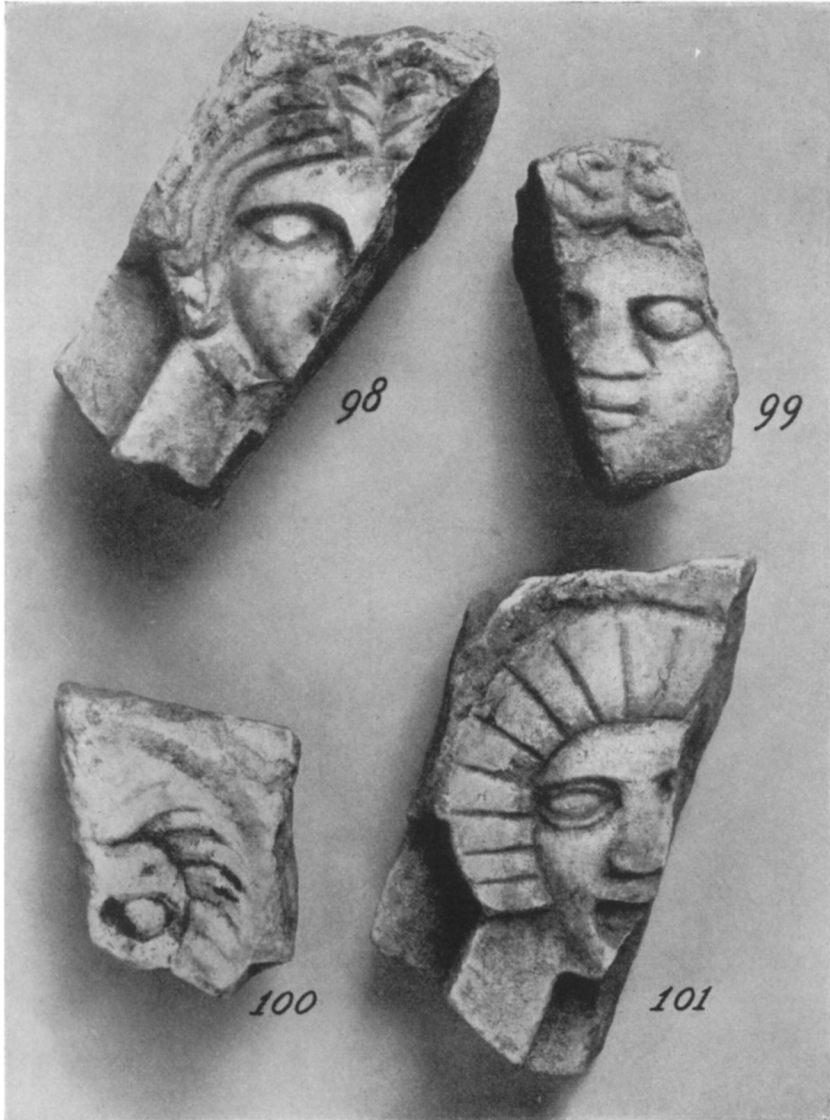
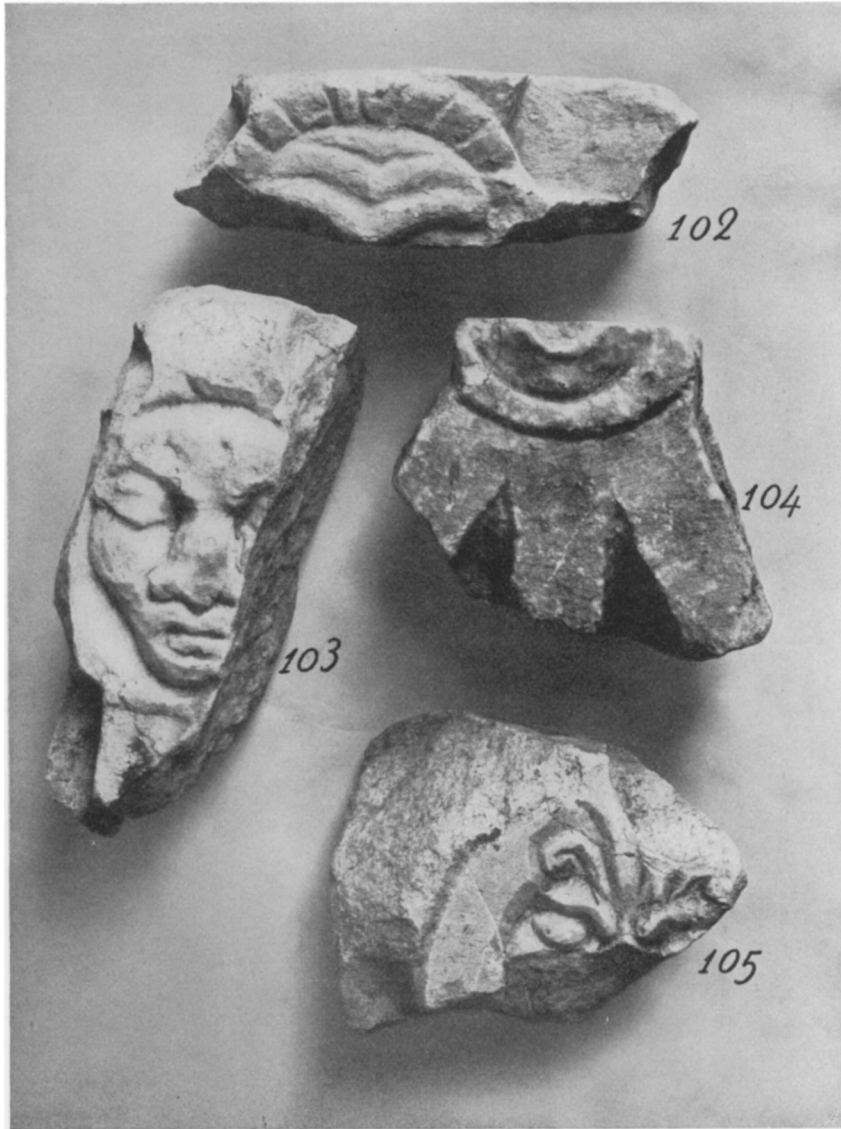
95–105. Figs. 106–110. Eleven fragments of reliefs with mask-like figures of Helios. There is little attempt at modelling; the features are merely carved in outline on the flat surface, and the background is cut back 0.02–0.03 m. The rays, which extend around the entire face, do not taper, but seem to have been connected to each other at the outer ends (Fig. 107). There is great variation among the heads both in the hair and in the other features. No original edge is preserved on any

of the slabs. Total thickness of the slabs 0.07–0.09 m. The heads measure ca. 0.16 m. in length and ca. 0.14 m. in width.

These queer figures probably decorated some part of the stage or the *scaenae frons*, but exactly what part is difficult to determine. One might suppose that they belonged to the decoration of a ceiling; but if that were the case, some fragment of the frames round the figures would doubtless be preserved. It is more likely that the slabs were used as decorations on the socle below the first row of columns. No slabs of this kind were found in the Odeum itself. The work is very careless, and it is evident that the architect did not treat these slabs as sculptured reliefs, but used the faces merely as patterns for the decoration of architectural members. The carving is not unlike that on some of the pilaster capitals (Figs. 88 and 89).

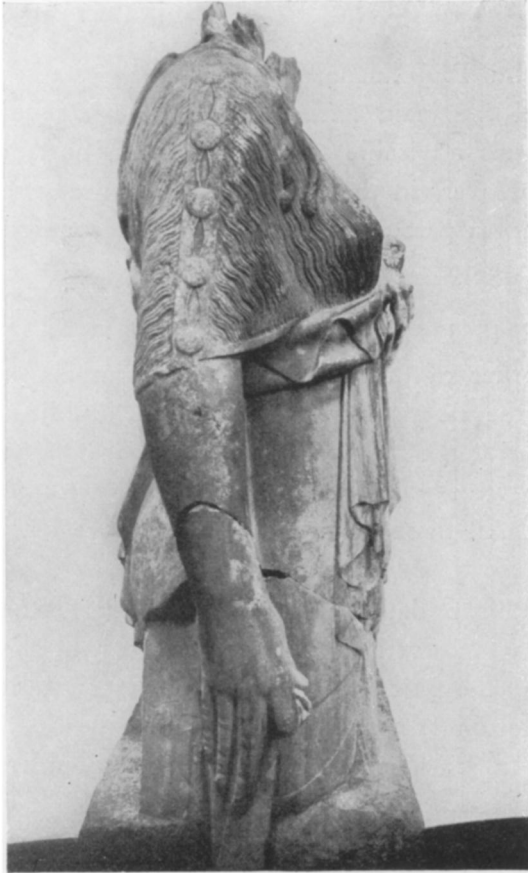
FIGURE 111. STATUE OF ATHENA, RIGHT SIDE

1. PLATES XV–XVI, Figs. 111–113. Inv. No. 1368. Statue of Athena with the owl, found April 5, 1928, in the northwest corner of the orchestra ca. 1.50 m. above the floor. It was lying front down in the débris from the wrecked building. A smaller piece (Inv. No. 1365), consisting of the right hand holding the drapery, was discovered June 3, 1927, in the same vicinity. With the statue were found also a few pieces of the hair and neck. All these smaller fragments have been fitted to the statue.

The drapery consists of an outer garment (*peplos*) and a *chiton* with sleeves. The *peplos* forms a *diplois* which passes over the left shoulder and under the right arm, leaving the *chiton* exposed on the right side both in front and in back. Below the *diplois*, three broad folds hang down in front,¹ one under the left arm, and one in the back. On the right side is a small fold, visible only in

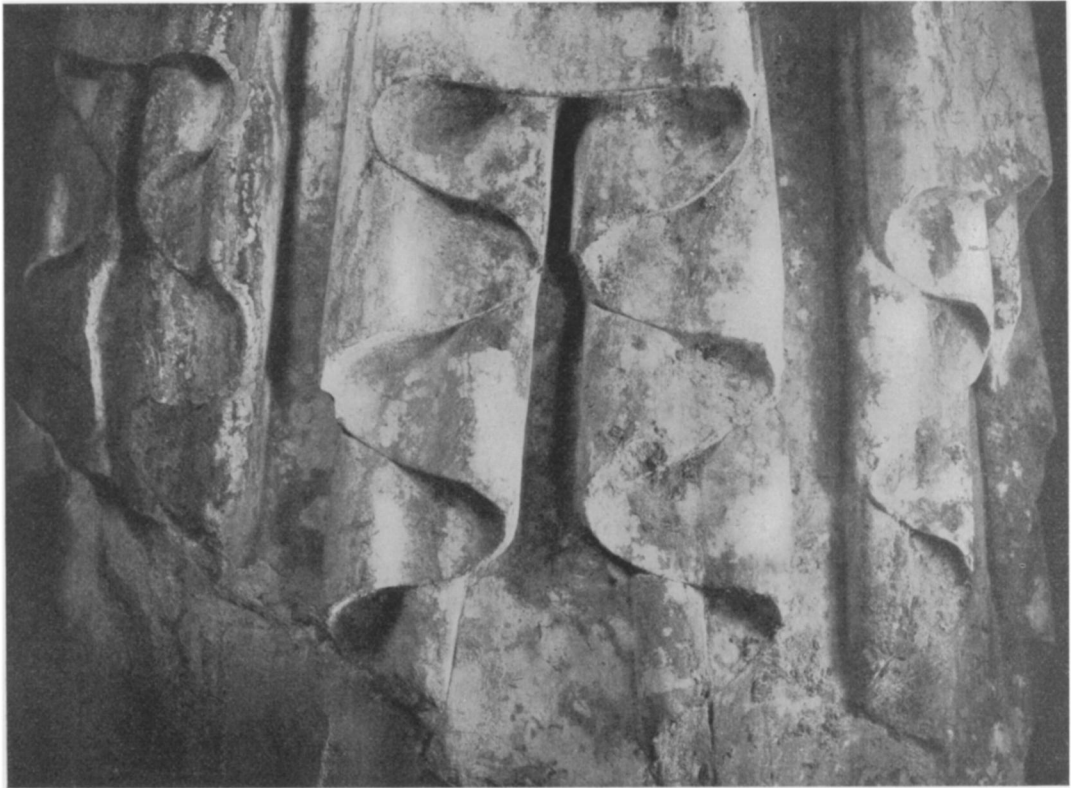
FIGURE 113. STATUE OF ATHENA, DETAILS OF DRAPERY

In technique the statue differs greatly from most Roman sculpture at Corinth. The drill appears to have been all but unknown to the sculptor. In two places only is there some indication that it may have been used. The zig-zag folds of the drapery were plainly all made with a chisel. The marble was not cut back under the folds (Fig. 113), as was commonly done by sculptors accustomed to work with the drill.

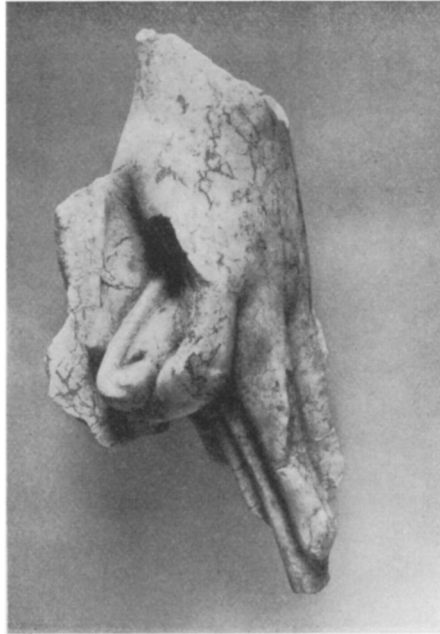
FIGURE 114. MARBLE HAND, HOLDING DRAPERY

2. Fig. 114. Inv. No. 1348 a and b. Left hand of archaistic statue holding drapery, found May 14, 1927. White marble, probably Pentelic.

The hand is held in exactly the same way as is the right hand of the preceding statue, the folds of the drapery in the two hands are identical, and the size is the same. The discovery of this fragment gives the clue to the peculiar pose of the Athena. The two statues were doubtless set up in close proximity, and the position of the hands of one had to be reversed in order to create a symmetrical arrangement.¹ From the place of finding it seems likely that both statues formed

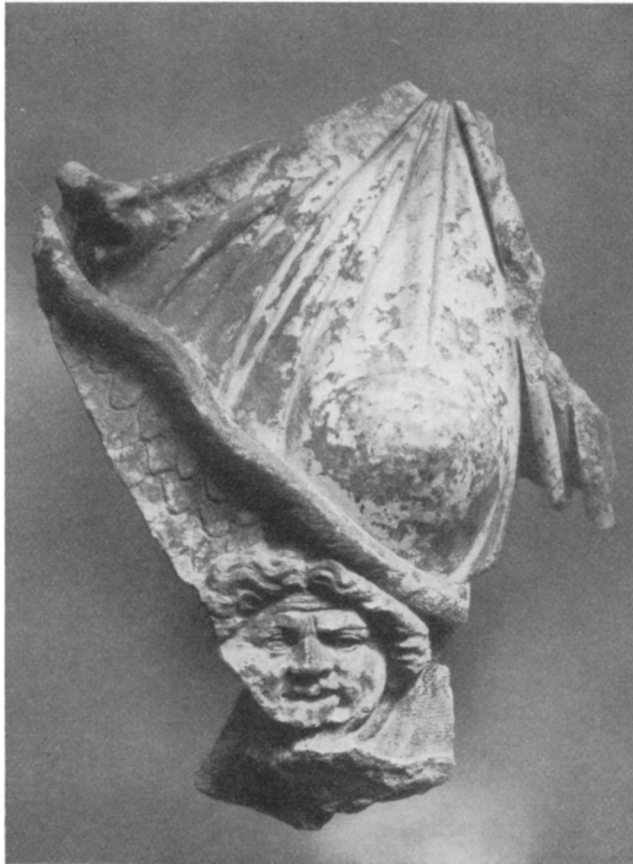
FIGURE 115. FRAGMENT OF ATHENA, WEARING AEGIS

3. Fig. 115. Inv. No. 1436. Fragment of a statue of Athena, approximately life size, found Nov. 21, 1930, in a pit dug to the south of the Odeum (p. 77). White

coarse-grained marble. Only the left breast and part of the aegis with the gorgoneion are preserved in one piece, but several smaller fragments of the statue were found in the same place, including the upper part of an arm with a dowel hole. Both the head and the arms were set in separately. The aegis is worn transversely as on the so-called Lemnian Athena,¹ with a small gorgoneion under the left breast. The scales of the aegis are carefully rendered. At the upper edge is a serpent. The texture of the drapery is indicated by fine marks of the rasp, whereas the nude parts were highly polished.

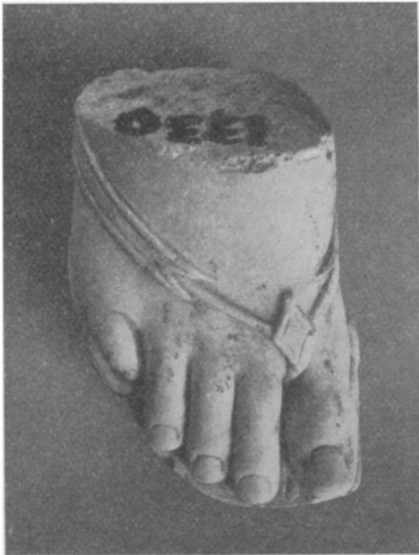
FIGURE 116. MARBLE FOOT

4. Fig. 116. Inv. No. 1330. Front part of a right foot wearing sandal, life size, found May 3, 1927, in the east part of the cavea. White

coarse-grained marble resembling that of the preceding fragment. The foot belongs to a statue with the drapery reaching to the ground and the right foot protruding from below. It shows no break, but is cut off obliquely at the instep and was added as a separate piece. It had no dowel, but was held in place by being partly sunk into the plinth or base. Only the upper edge of the sandal is carefully finished, since the lower part was hidden. The modelling is careful and the surface is highly polished. Though found at some distance from the preceding fragment, it is not unlikely that it belongs to the same statue. The marble, which is not a very common variety in Corinth, is similar in the two pieces; both belong to a statue of about life size; the highly polished surface and the careful workmanship are common to both; and the attached foot protruding from under the long drapery could belong

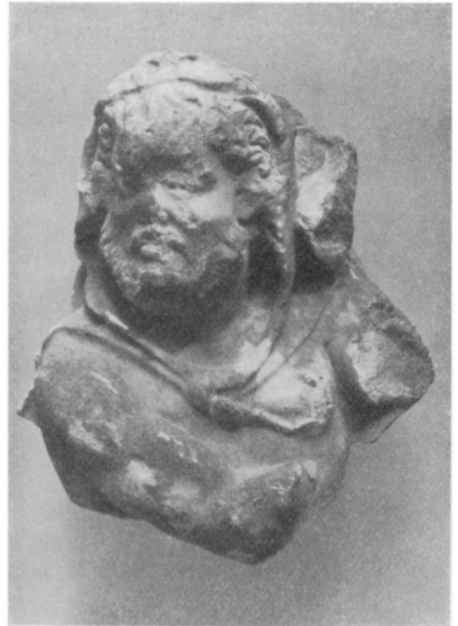
FIGURE 117. FRAGMENT OF RELIEF WITH
FIGURE OF HERACLES

5. Fig. 117. Inv. No. 1363. Fragment of relief with the figure of Heracles, found May 26, 1927 near the northeast corner of the orchestra. White fine-grained marble. Only the head and the breast are preserved. The lion's skin hangs over the head and is tied in front. Both hands were extended to his left, holding some object, perhaps the club, a piece of which remains on the left side of the head. The eye balls have deep, double incisions made with the drill.¹ The figure is slightly less than half life size.

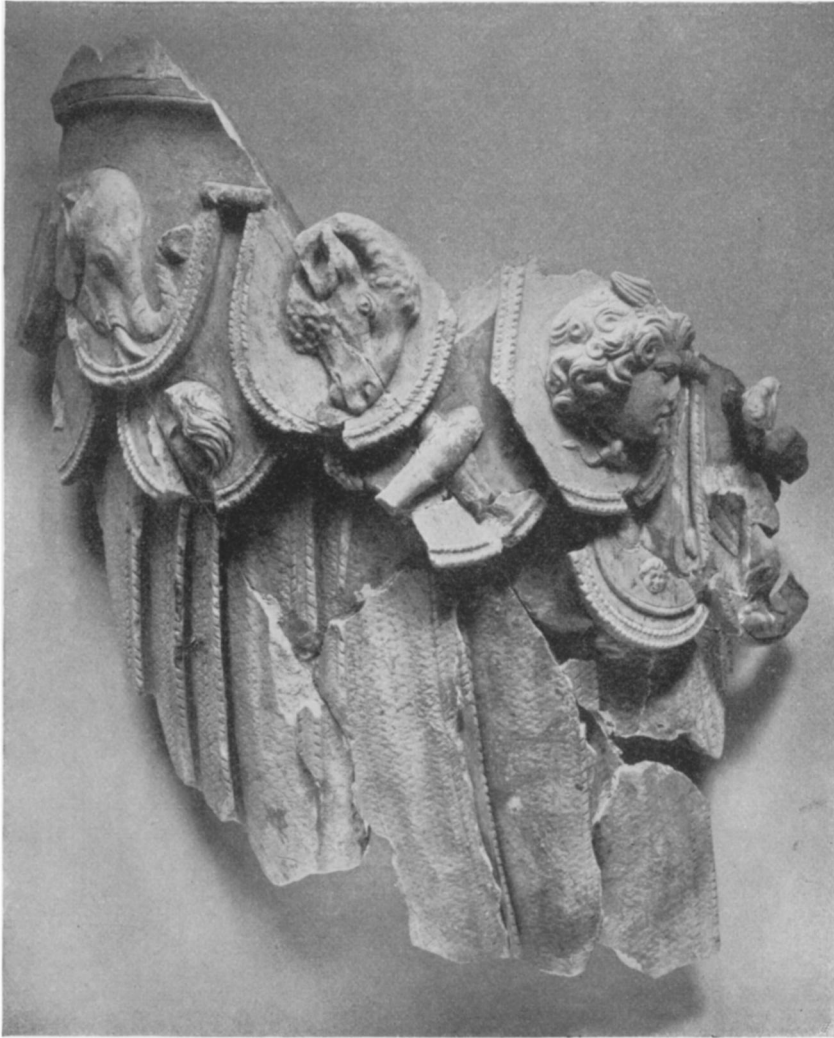
FIGURE 118. FRAGMENTS OF STATUE, SHOWING RELIEFS ON LAPPETS

6. Figs. 118–126. Inv. No. 1456. Fragments of a *statua loricata* discovered June 14 and 15, 1928 among the débris that filled the curtain channel. White fine-grained marble, probably Pentelic. Most of the statue was destroyed by the fire which ruined the building in the early part of the third century, and the fragments which remain are badly burned. It has been possible to join some of the best fragments from the right side of the torso about the waistline (Fig. 118). Two rows of lappets with figures in relief were fastened to the lower edge of the cuirass, and below was a kilt of leather straps with fringes.

elephant's head, both in rather low relief. The elephant's head is the last relief on the right side. The next lappet and apparently all those on the back were undecorated. A small fragment of the first plain lappet is preserved with the large piece (Fig. 118), and another fragment from the back shows that both rows of lappets there were plain. The upper row partly overlaps the lower, hence the reliefs on the lower row are small. The lower lappet between the eagle and the

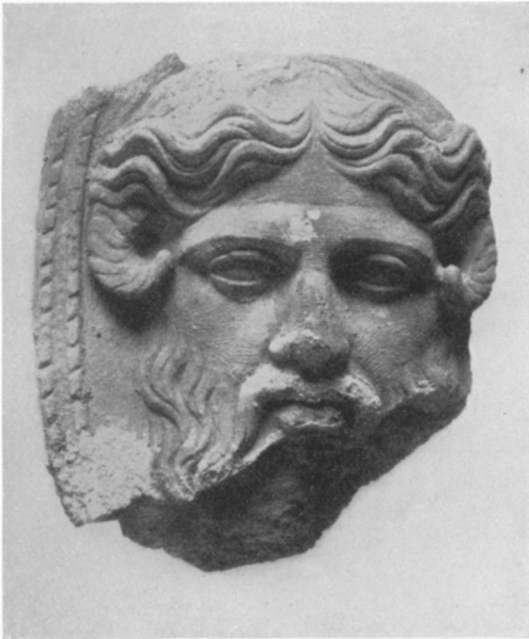
FIGURE 119. MEDALLION WITH HEAD OF ZEUS
AMMON

The arrangement of the reliefs on the lappets of the upper row can be determined with certainty. In the middle was a head of Zeus Ammon in front view (Fig. 119). The hair is parted in the middle, and at the temples small horns curve around to the corners of the eyes. The chin and most of the beard are missing. All the features of the head are modelled with the greatest care, and the artist has succeeded in creating an expression of dignity and grandeur seldom attained in miniature reliefs of this kind.

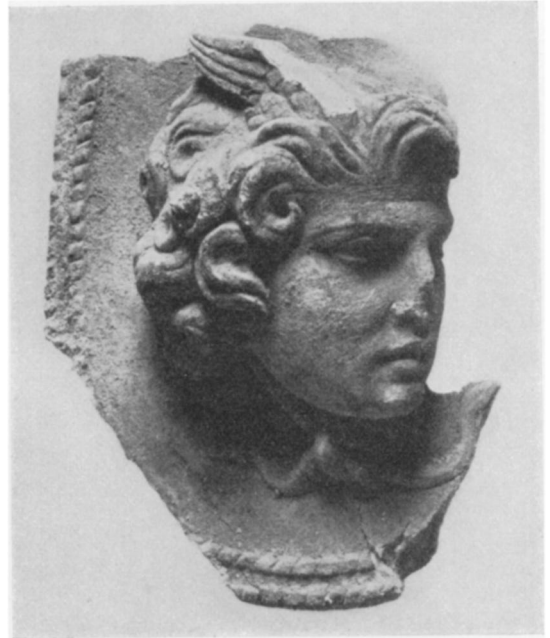
FIGURE 120. MEDALLION WITH GORGONEION

with a gorgoneion of the "good looking type" in high relief (Fig. 120). The head is turned to the right in half profile. Round the neck are two serpents tied in a knot, and on the head are two small wings. The rendering of the hair, which falls in heavy, deeply separated locks, is reminiscent of some of the

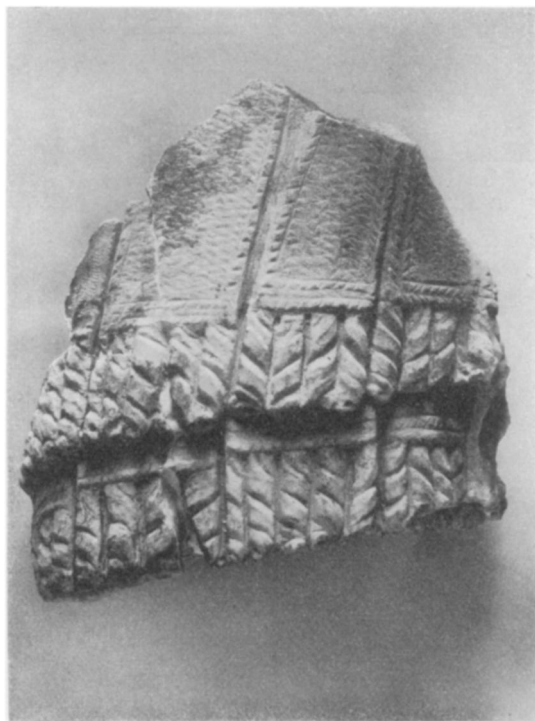
FIGURE 123. FRAGMENT OF SHOULDER DECORATION

shoulders (Fig. 123). The head was made in a separate piece as is indicated on some fragments of the *paludamentum* which was thrown about the neck. One of the arms also was made separately, and the same seems to have been the case with the legs below the kilt. A fragment of the right leg (Fig. 124), broken below the knee, preserves the boot made of a panther's skin. A garter consisting of two serpents with a link in their mouths holds up the boot. The support on

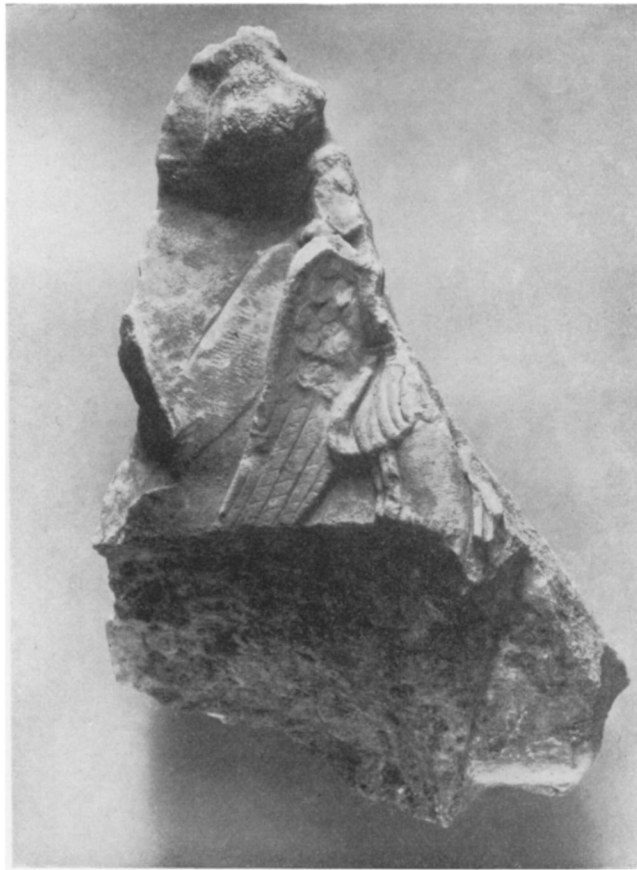
FIGURE 128. FRAGMENT OF STATUA LORICATA

7. Fig. 128. Inv. No. 1430. Fragment of a *statua loricata* found built into a late wall at the northwest corner of the Odeum. White fine-grained marble. Part of the cuirass is preserved with the figure of a winged Nike to the right.¹ The end of the right epaulet appears above the Nike. A fragment of a support in the form of a tree trunk found in the same wall probably belongs to it. The carving of these pieces is vastly inferior to that of No. 6, and the statue was probably smaller.

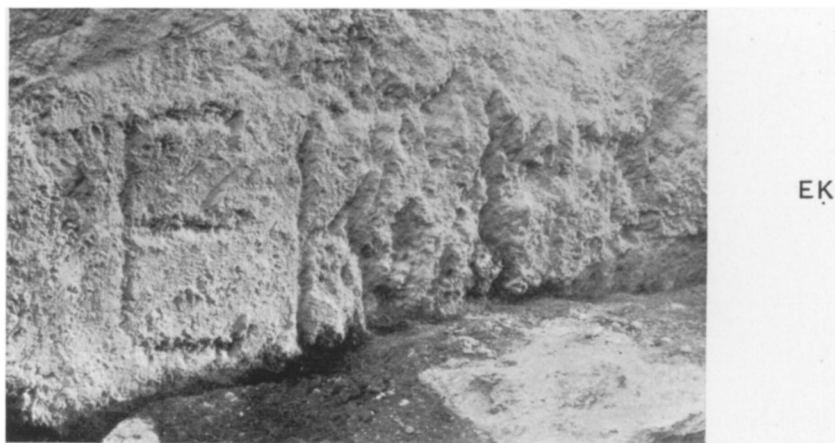
FIGURE 132. INSCRIPTION NO. 5

5. Fig. 132. Inv. No. 1065.

The letters are cut in the rough surface of the scarp of rock, directly above the wall between chambers IV and V on the south side. When the wall was preserved

to its full height the letters were not visible, hence they were probably cut at the time when the stone quarry was worked. Height of letters 0.18 m.

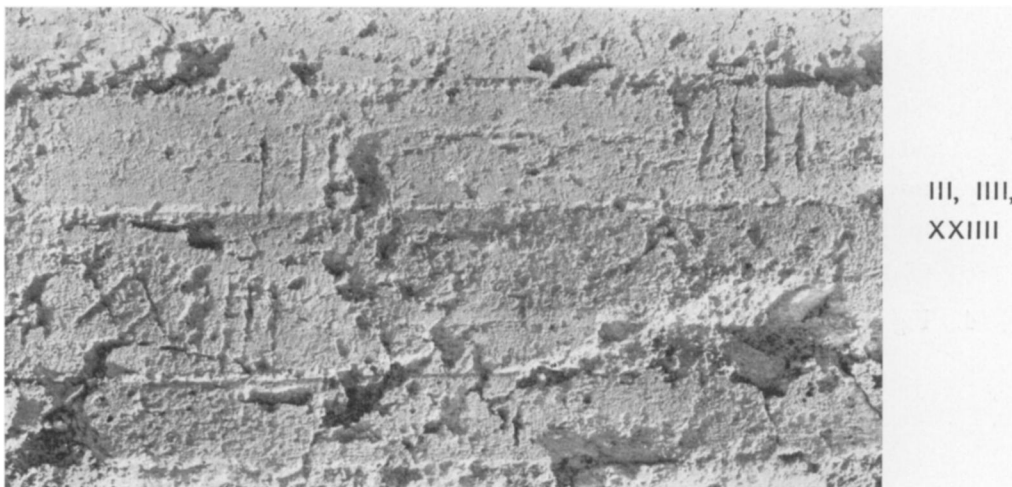
FIGURE 133. INSCRIPTION NO. 6

6. Fig. 133. Inv. No. 1066.

Roman numerals scratched on the surface of a piece of concrete vaulting near the west stairway in the cavea. As the piece is now lying, the letters are upside down; but in figure 133 they are shown right side up. Height of numerals ca. 0.10 m.

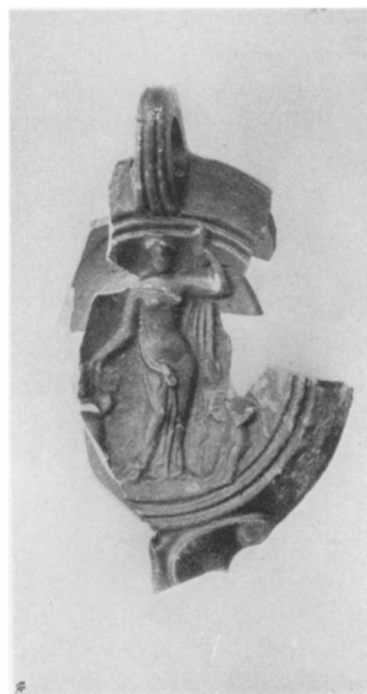
FIGURE 138. LAMP FROM FOUNDATION OF SOUTH STAIRWAY

4. Fig. 138. Roman lamp found embedded in the mortar of the foundation for the south stairway (p. 31). On the discus is the figure of Aphrodite, holding up the drapery, behind her in her left hand. The lower part of the drapery is wound around her

The south foundation, though obviously belonging to the Odeum, is not in any way joined to the outer wall of the cavea. It was certainly laid after the wall was already built to the height of the first story. Still it cannot have been built much later than the rest of the building, as is indicated by the fill around it. One piece of evidence for its date is given by a lamp which was found clinging to the mortar of the foundation. Between piers C and D, a narrow trench was cut across the foundation in order to obtain evidence for its date. The mortar was here so soft that the stones could be picked out with the hands, and in this masonry the fragments of the lamp shown in figure 138 were discovered. The lamp belongs to a type which was in use in Corinth about the middle of the first century A.D. (see p. 141).
