HESPERIA: SUPPLEMENT III

THE SETTING OF THE PERICLEAN
PARTHENON

GORHAM PHILLIPS STEVENS

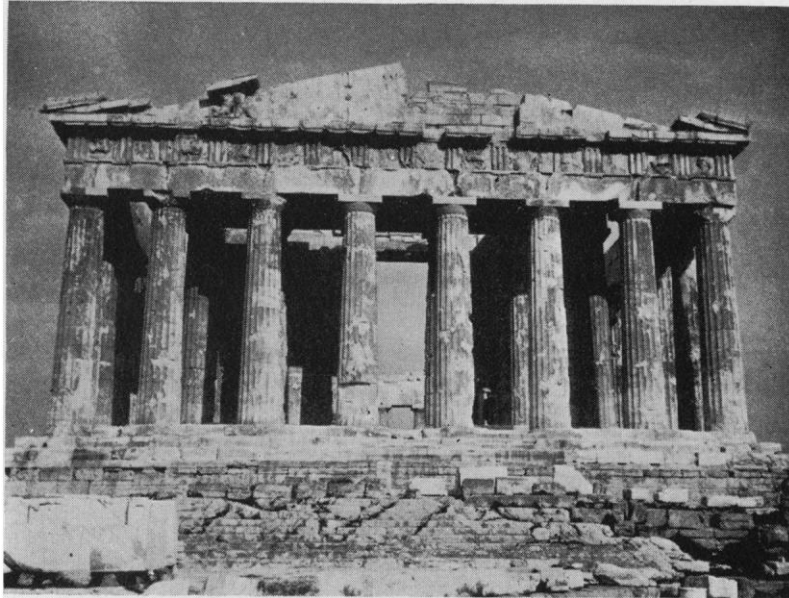
Fig. 3. The West Façade of the Parthenon, Photographed on the Axis of the Temple

for example, in the case of the temples of the Imperial Fora in Rome; only the width and height of the temples could be appreciated from such an approach, and the observer had to imagine how many columns there were along the sides. A comparison of the Frontispiece and Figure 3 strikingly shows the advantage of the approach located somewhat to one side over the approach along the main axis.

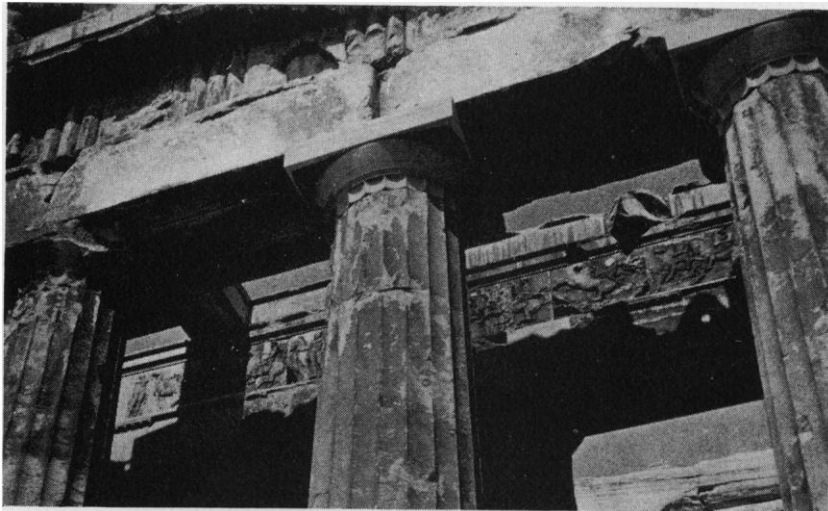
Fig. 43. Panathenaic Frieze Viewed from the West Terrace of the Parthenon

pedestals in the entire area under consideration.³³ The area seems to have been unencumbered with monuments so that people might circulate over a terrace from which they could admire the temple and especially the beautiful Panathenaic frieze, which, it will be remembered, was carved along the top of the cella wall, and which could only be well seen from the terrace (cf. Figs. 4 and 43).³⁴

indication of where Ictinus and Phidias intended people to gather. Probably antiquity does not present a better example of collaboration between architect and sculptor than in the happy solution of this problem (Figs. 4 and 43).

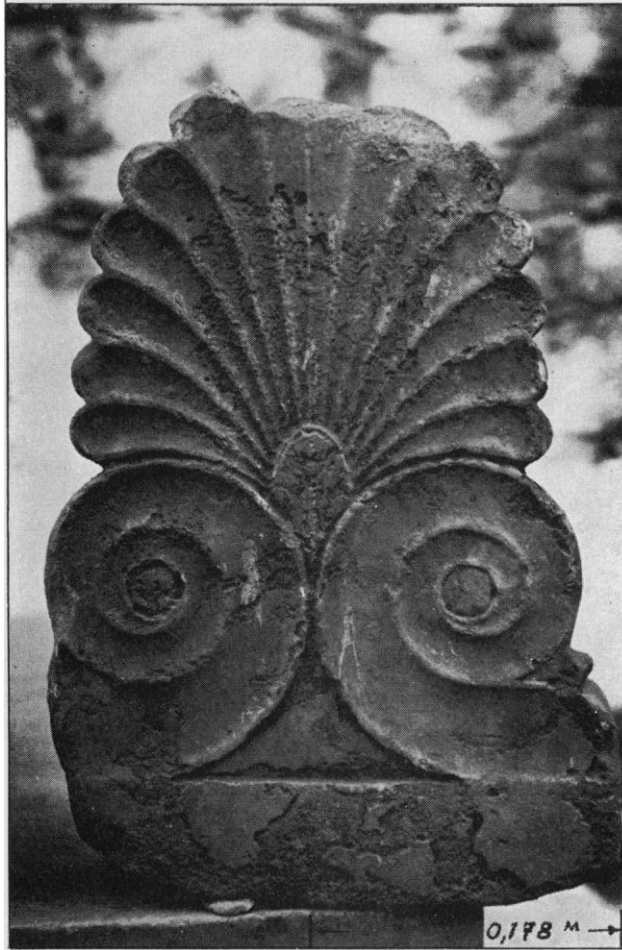
Fig. 46. Antefix of the Parthenon
(Acropolis Museum, Athens)

Many of the antefixes are preserved. Their spacing is known, both from weather marks and from the dowel cuttings used in holding them in place. They are an excellent example of architectural ornament (Fig. 46).

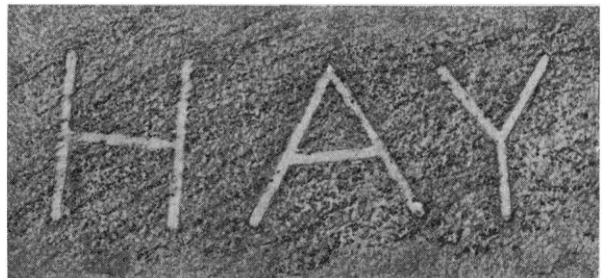
Fig. 53. The Inscription of Fig. 52, from a Rubbing (1:1)

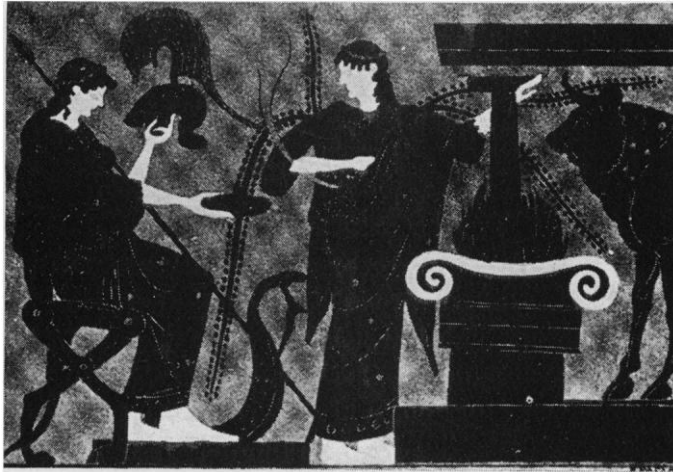
Fig. 63. Hydria in Berlin: Ox in Shrine

figured vase-painting from a hydria — — —” (which I illustrate in Fig. 63 from Harrison, *Mythology and Monuments of Ancient Athens*, p. 428, fig. 37). “To the right, actually within a small Doric shrine, stands an ox; in front, a blazing altar; outside stands a woman, who must be a priestess; and to the left is seated Athene, with her helmet in her left hand, a phiale⁶⁴ in her right. Her sacred snake uprears himself in front of her. It might be said this merely represents the sacrifice of an ox to Athene — — — It is, however, noticeable that the ox here is within the temple, and seems to be the object of reverent attention; the goddess is without: the ox is not bound, as usually for sacrifice, but free and stately. I cannot avoid the idea that this represents the sacred ox in his Boukoleion, whether it be the building below the Acropolis or some shrine of the Polieus, and that the goddess Athene is there to recognize his sanctity and pay some tribute, as on the occasion of her first sacrifice to Zeus.”⁶⁵
